# 2025 CCR Annual Report

**Dairyland Power Cooperative  
Alma Off-Site Disposal Facility  
Phase IV Landfill  
Town of Belvidere, Wisconsin**

**License 4126**

Subject: Alma Off-Site Disposal Facility – Phase IV Landfill  
2025 Annual Inspection by a Professional Engineer

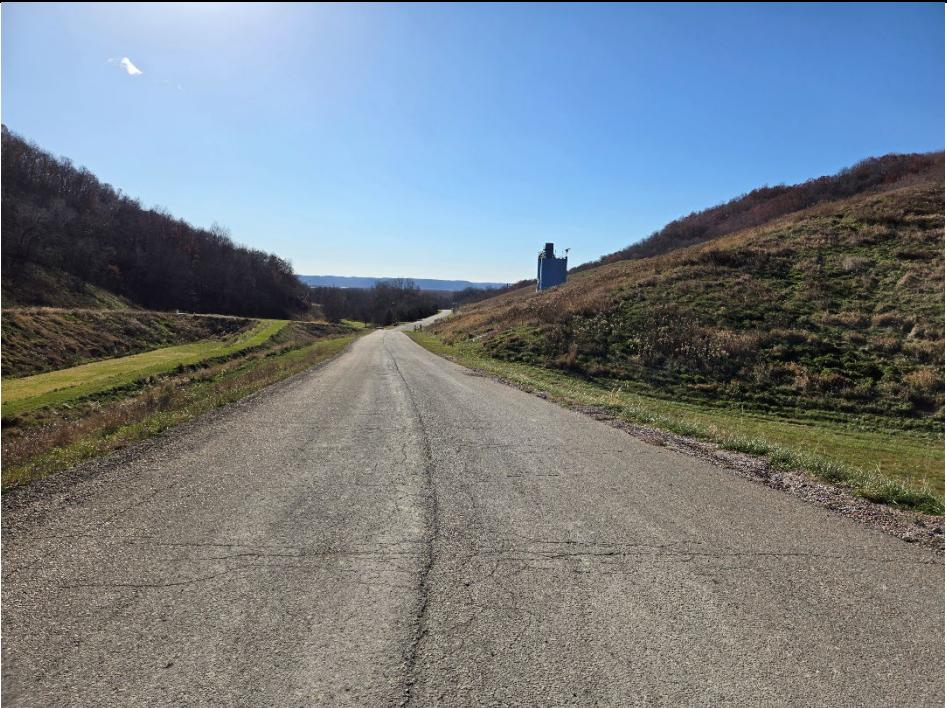
<b>Description:</b> Asphalt paved site entrance road looking south towards the entrance to the facility and Highway 35.				
Photo No.	Date			
2	11/12/2025

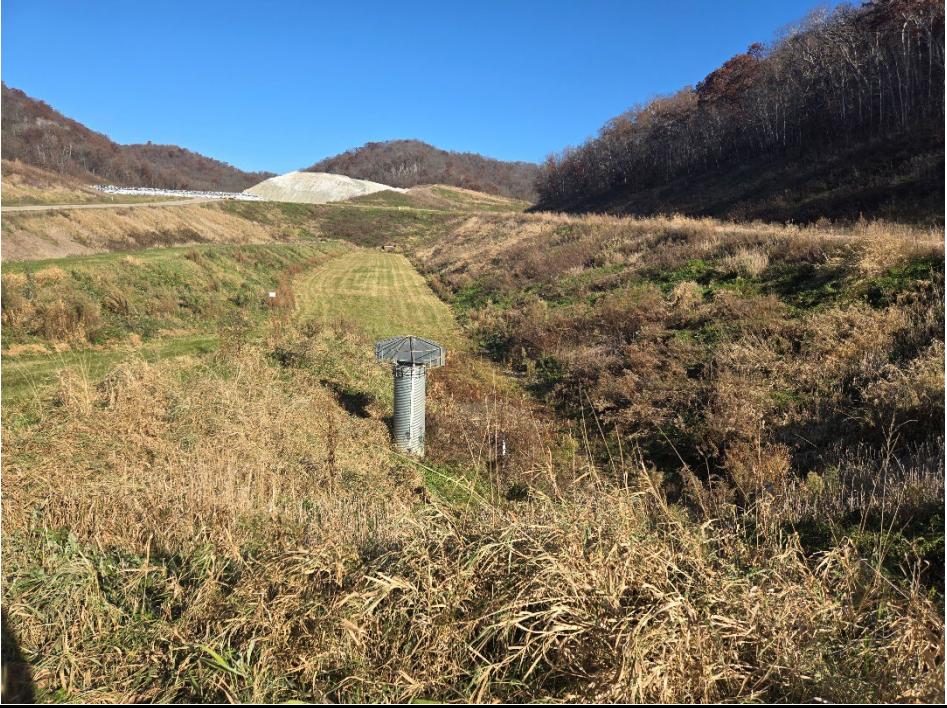
<b>Description:</b> Sedimentation Basin 1 outlet. Vegetation established at the base. Gravel placed surrounding base of outlet pipe. No distressed vegetation or sloughing observed on the sideslopes. Scattered sparse vegetation observed due to wild parsnip removal activities. No standing water observed.

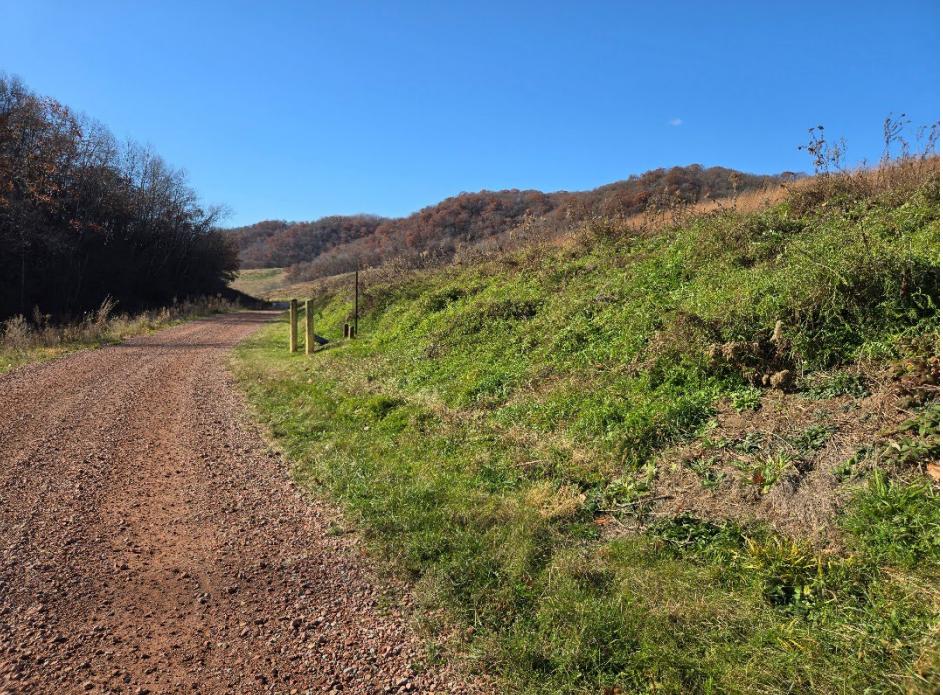
<b>Description:</b> Perimeter road is well maintained and provides access to the east and north sides of the landfill. Leachate headwell protected by bollards. In background of photo, vegetation established on Area 1 and Area 2 final cover. Some sparse vegetation areas due to woody vegetation and wild parsnip removal.

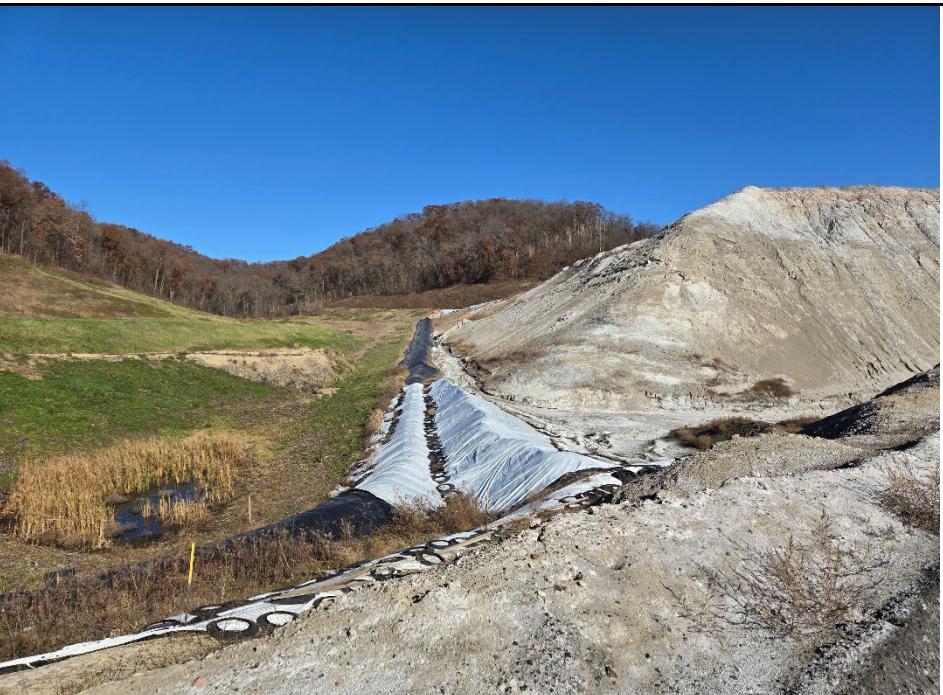
4	11/12/2025

Cell Delineation Berms: Exposed geomembrane observed to be in good condition, berm maintains freeboard to contain runoff within the cell; however, some deposits of CCR were observed along the cell delineation berm as a result of erosion of the CCR working face.

<b>Description:</b> CCR filling area showing the Cell 3 delineation berm. There is some sediment buildup at the toe of the delineation berm that should be relocated to maintain temporary storage capacity for contact water.

Comments: Exposed geomembrane does not show signs of deterioration or damage. Material that migrated off the working face should be relocated to maintain temporary storage capacity for contact water.

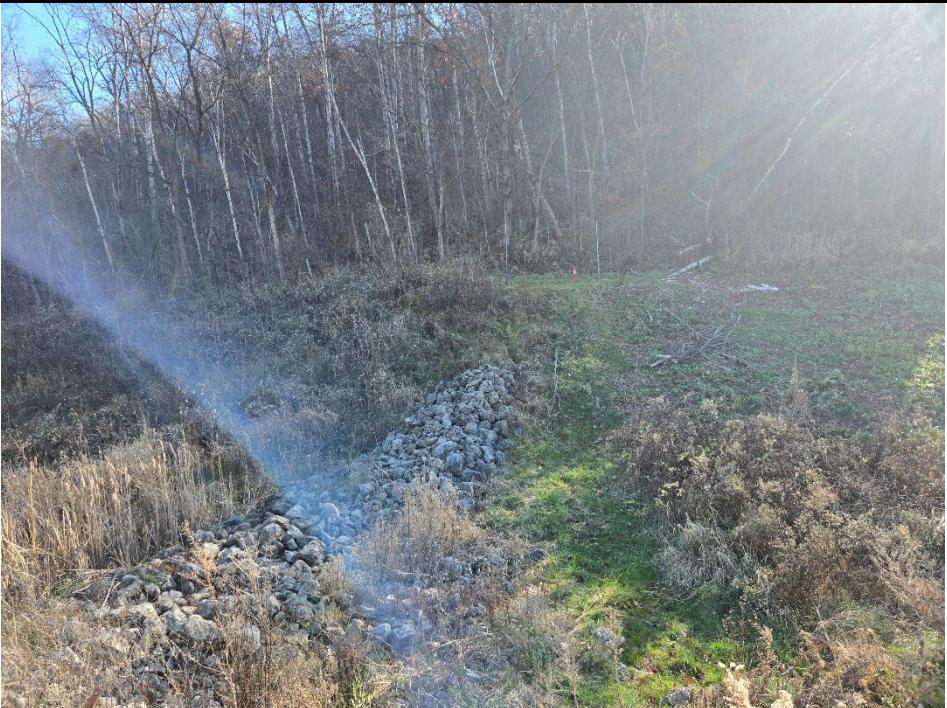
<b>Description</b> Perimeter drainage ditch with rock check dam.				
Photo No.	Date			
6	11/12/2025

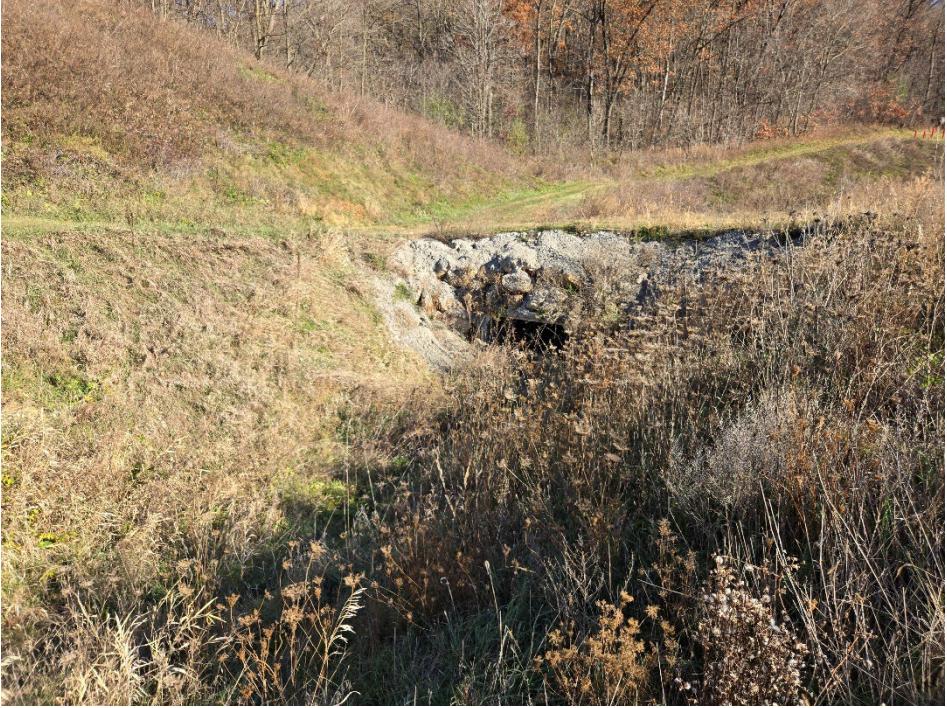
<b>Description:</b> Box culvert to accommodate storm water conveyance around perimeter of site. Grouted riprap protects sideslopes at transition. Woody debris observed in portions of drainage ditches. No obstructions observed at the culvert or at conveyance structures.

Comments: Continue to keep drainage ditches clear. Remove branch debris from drainage ditches. Continue to monitor ditches for woody vegetation and clear the vegetation when observed. Continue to inspect for ponding within the drainage ditches, regrade if significant ponding is observed. No other concerns at this time.

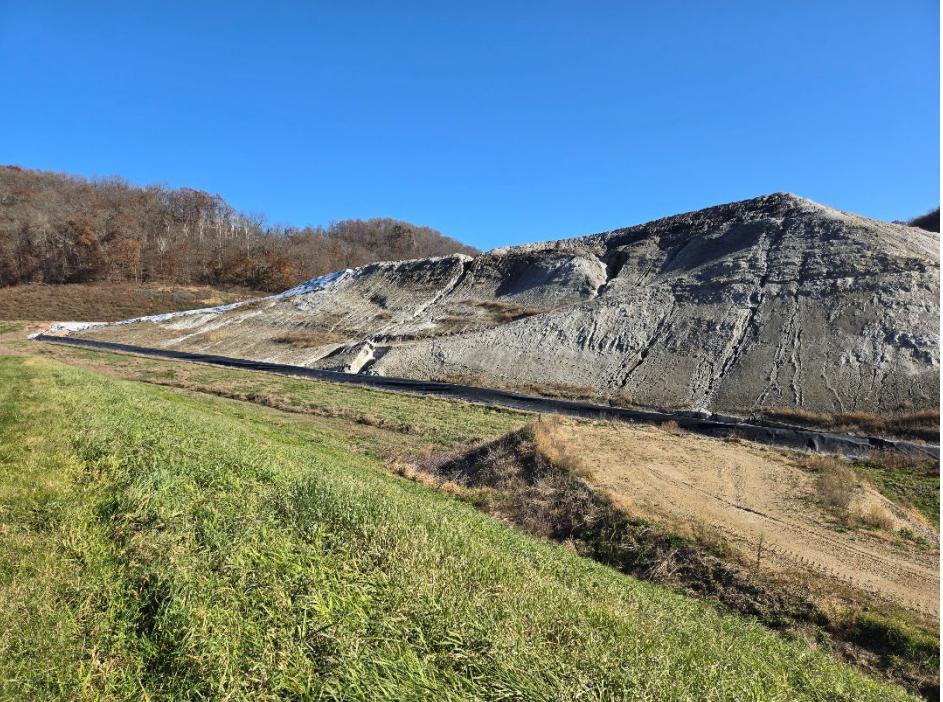
Working Face Conditions: Evidence of erosion was observed on the operational face of the landfill with migrated CCR observed within the containment berm ditch. Erosion on the working face should be monitored and stabilized. Migrated CCR should be relocated to ensure sufficient freeboard is maintained along the delineation berm.

<b>Description:</b> Active filling area of the landfill (Cell 3A and 3B). Phase delineation berm in the foreground. Erosion noted on working face. No evidence of unstable conditions.				
Photo No.	Date			
8	11/12/2025

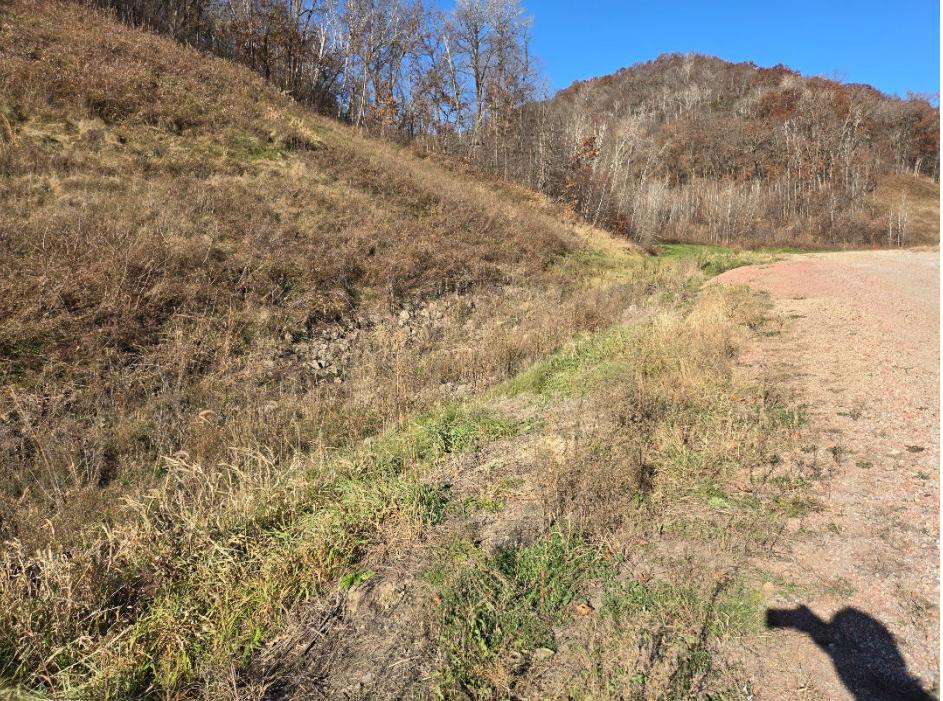
<b>Description:</b> Grouted riprap in perimeter ditch displays no signs of undermining. Vegetative growth not impacting performance. Dense vegetation is established around ditch and ditch is clear of obstructions.

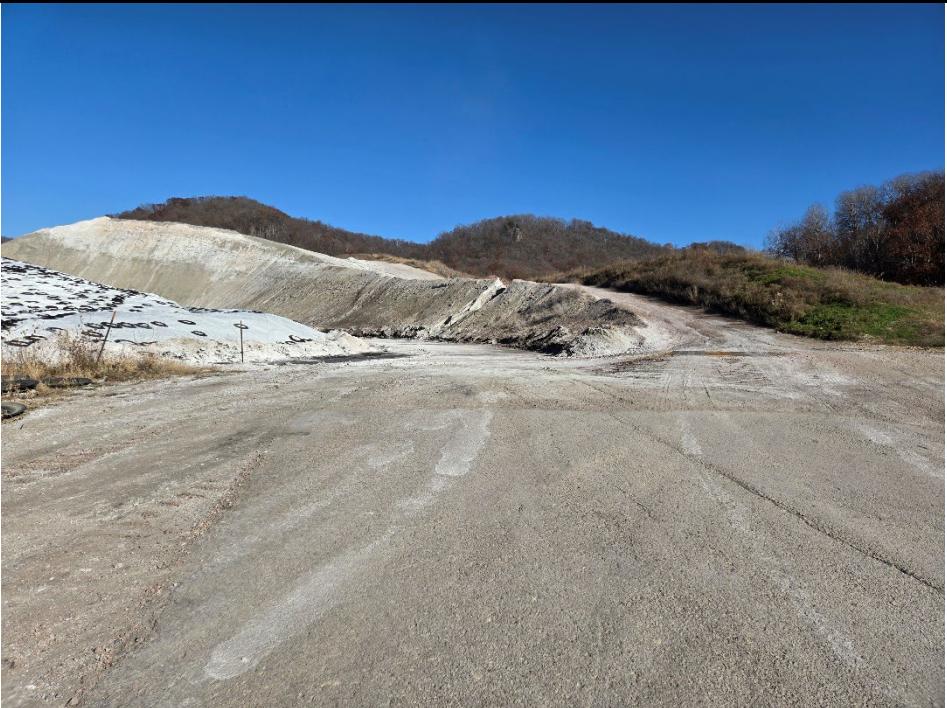
Durable, paved, well groomed, appreciably free of CCR at egress from Phase IV. Appears to be routinely swept and well maintained. Minor staining observed at start of paved surface from Phase IV.

<b>Description:</b> Asphalt paved access road at entrance to filling area. Minor staining observed on the paved surface.				
Photo No.	Date			
10	11/12/2025

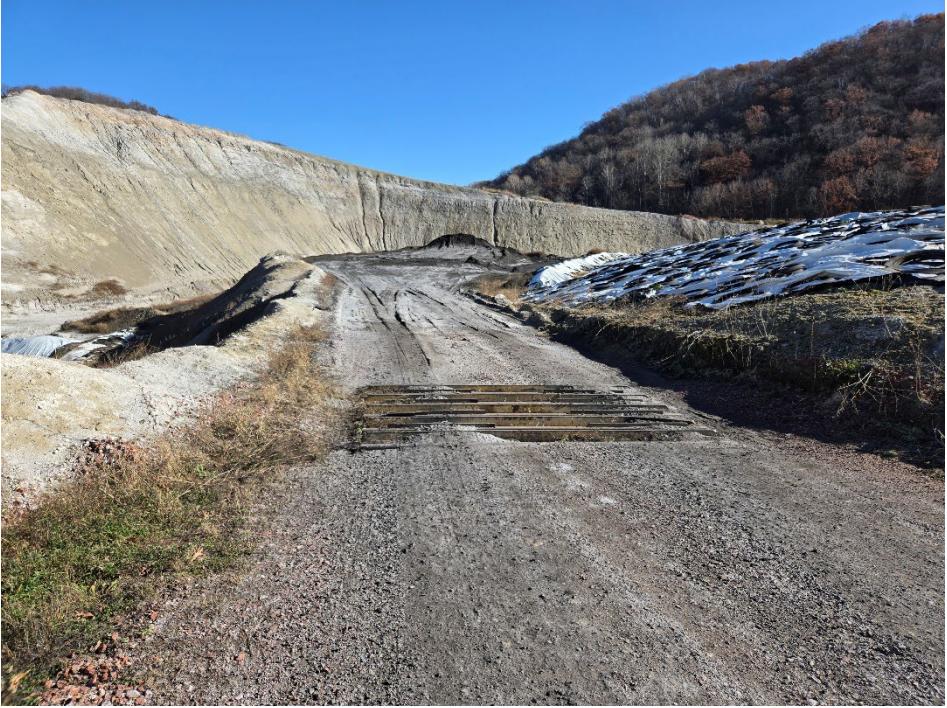
<b>Description:</b> Wheel shakers installed at egress of Phase IV Landfill to minimize tracking of CCR material outside the permitted limits of waste.

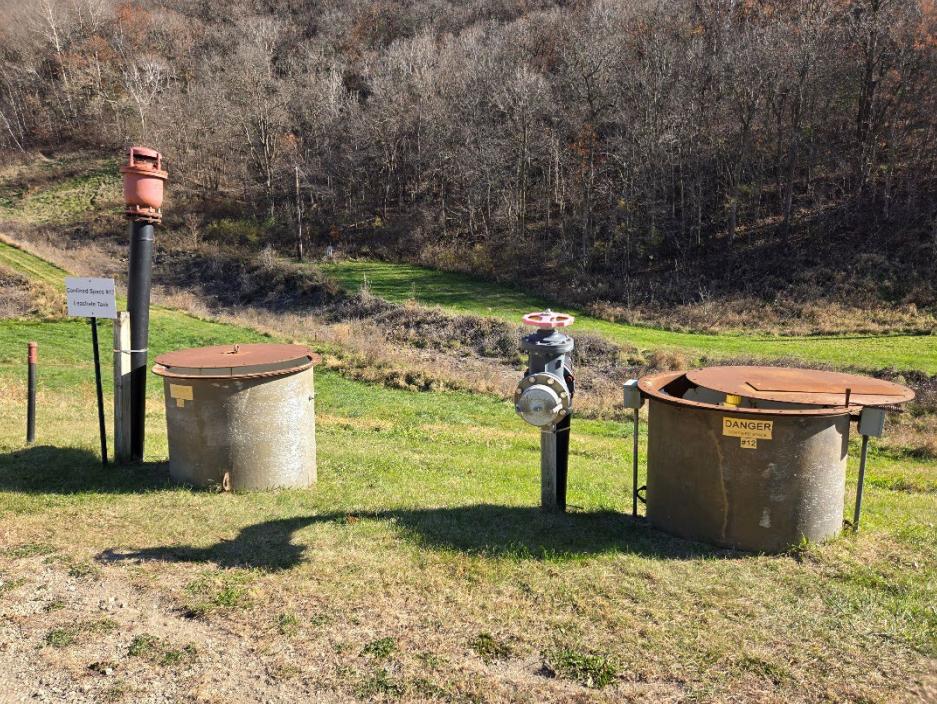
<b>Description:</b> Leachate tank surface features; clear, accessible, and in good working order. Observed leachate flowing into the tank.
