Subject: Alma Off-Site Disposal Facility – Phase IV Landfill
2025 Annual Inspection by a Professional Engineer

PROJECT/PROPOSAL NAME	PREPARED		CHECKED		PROJECT/PROPOSAL NO.
	By:	Date:	By:	Date:	
Dairyland Power Cooperative Phase IV, Alma Off-site Disposal Facility	B. Kahnk	11/21/2025	T. Martin	11/26/2025	624404.0000

Landfill Annual Inspection Report

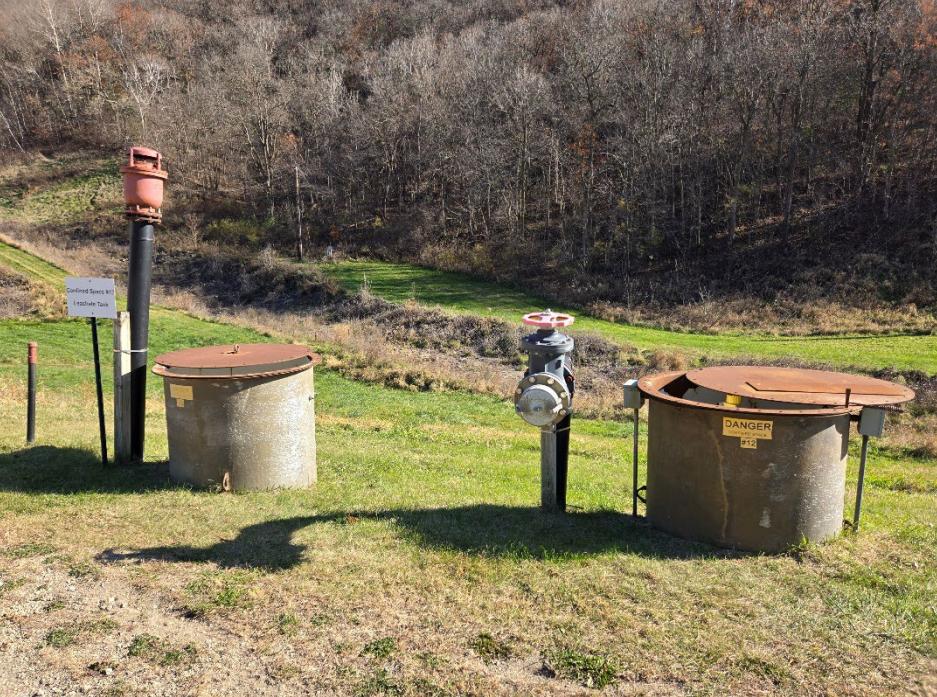
Description: Leachate tank surface features; clear, accessible, and in good working order. Observed leachate flowing into the tank.
