Subject: Alma Off-Site Disposal Facility – Phase IV Landfill  
2022 Annual Inspection by a Professional Engineer

PROJECT/PROPOSAL NAME Dairyland Power Cooperative Phase IV, Alma Off-site Disposal Facility	PREPARED		CHECKED		PROJECT/PROPOSAL NO. 469888.0000
	By: B. Kahnk	Date: 11.21.2022	By: T. Martin	Date: 12.05.2022

### Landfill Annual Inspection Report

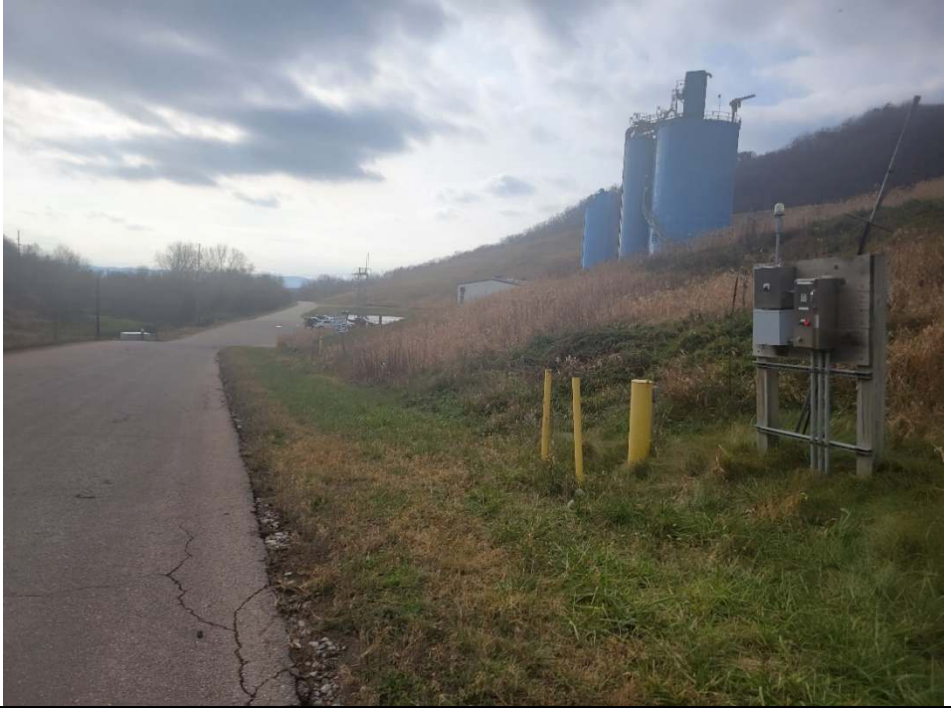
Photo No.	Date	Image
1	11/09/2022

<b>Description:</b> Asphalt paved site entrance road looking towards the entrance to the facility.

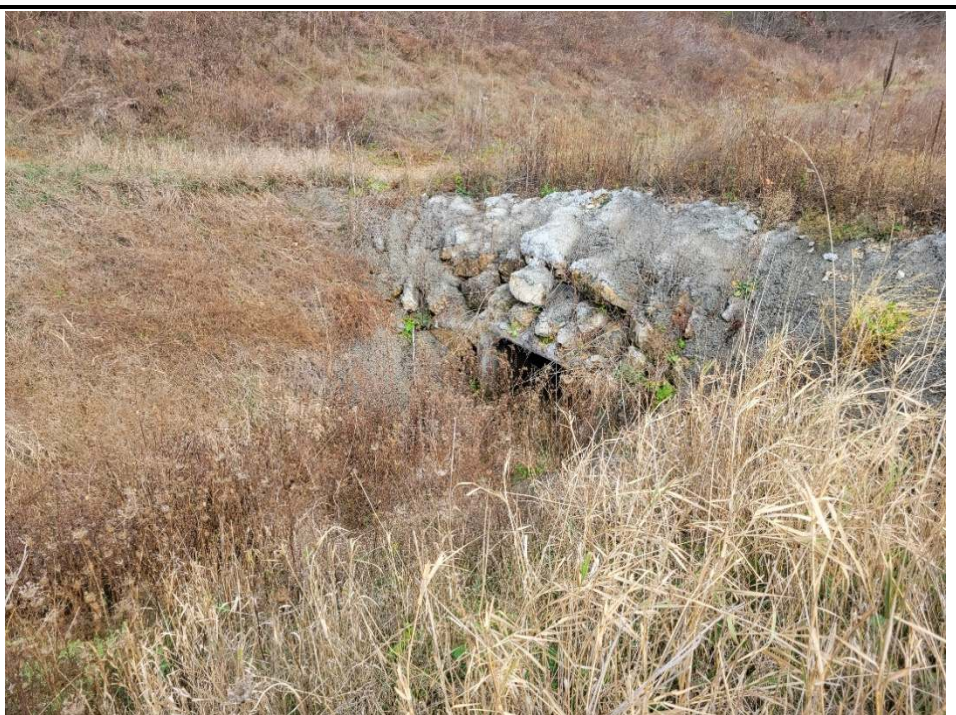
<b>Photo No.</b> 6	<b>Date</b> 11/09/2022

<b>Description:</b> Box culvert to improve storm water conveyance around perimeter of site. Grouted riprap protects sideslopes at transition. No obstructions observed in the perimeter ditch or at conveyance structures.

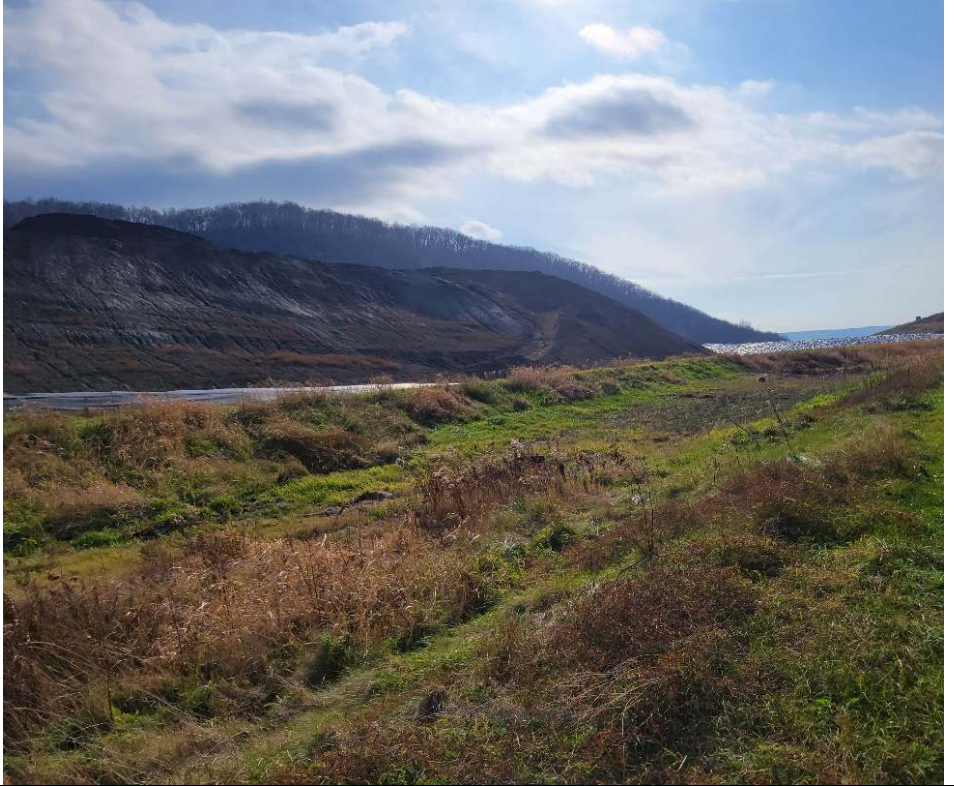
<b>Photo No.</b> 7	<b>Date</b> 11/09/2022

<b>Description:</b> Active filling area of the landfill (Cell 3A and 3B). Phase delineation berm in the foreground. No evidence of unstable conditions. No fugitive dust observed.

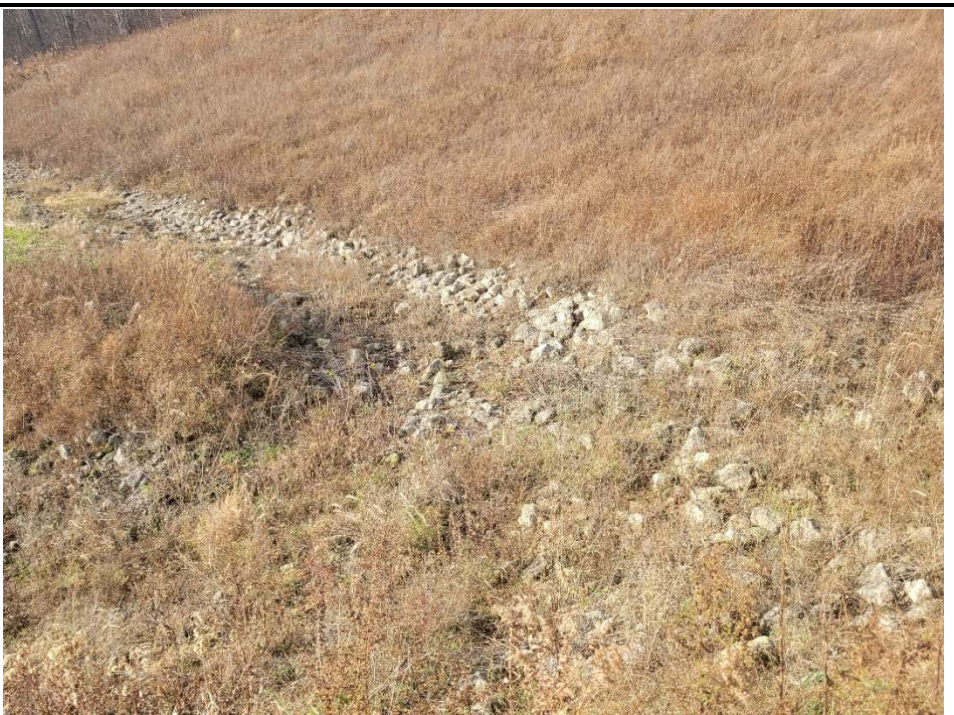
<b>Photo No.</b> 8	<b>Date</b> 11/09/2021

<b>Description:</b> Riprap ditch protection in perimeter ditch. Minor vegetative growth not impacting performance. Dense vegetation is established around ditch and ditch is clear of obstructions.

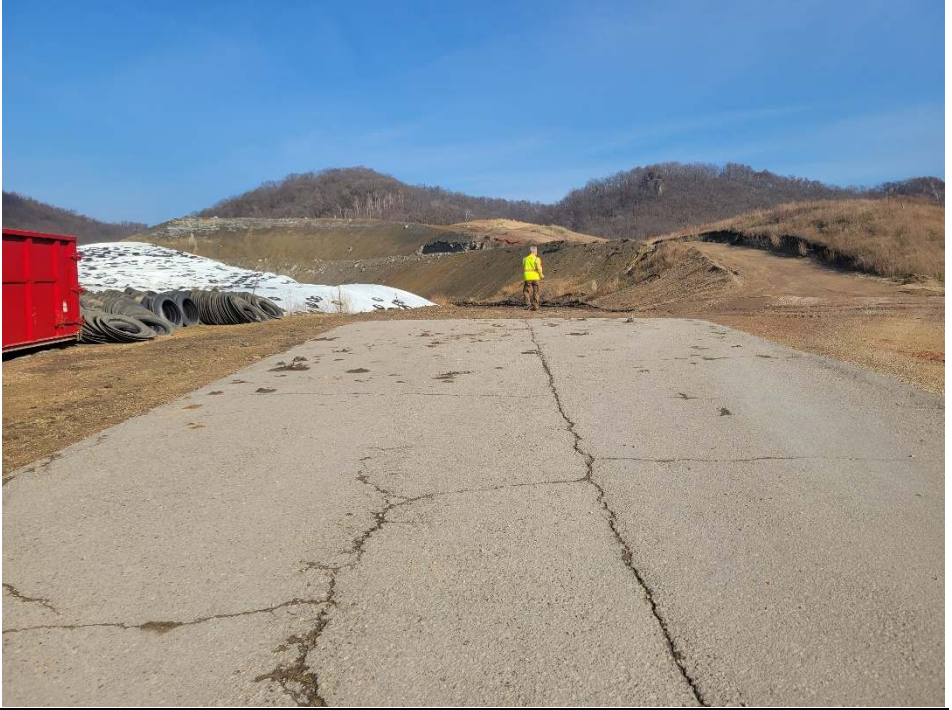
<b>Photo No.</b> 9	<b>Date</b> 11/09/2022

Durable paved, well groomed. Very minor tracking of a soil and ash mixture observed at egress from Phase IV (northern approximately 50 feet of paved surface). No tracking was observed on the remainder of access road.

<b>Description:</b> Asphalt paved access road at entrance filling area. Minor tracking of a mix of soil and ash observed at egress from Phase IV.

Comments: Sweep landfill egress as needed, especially following rain events.

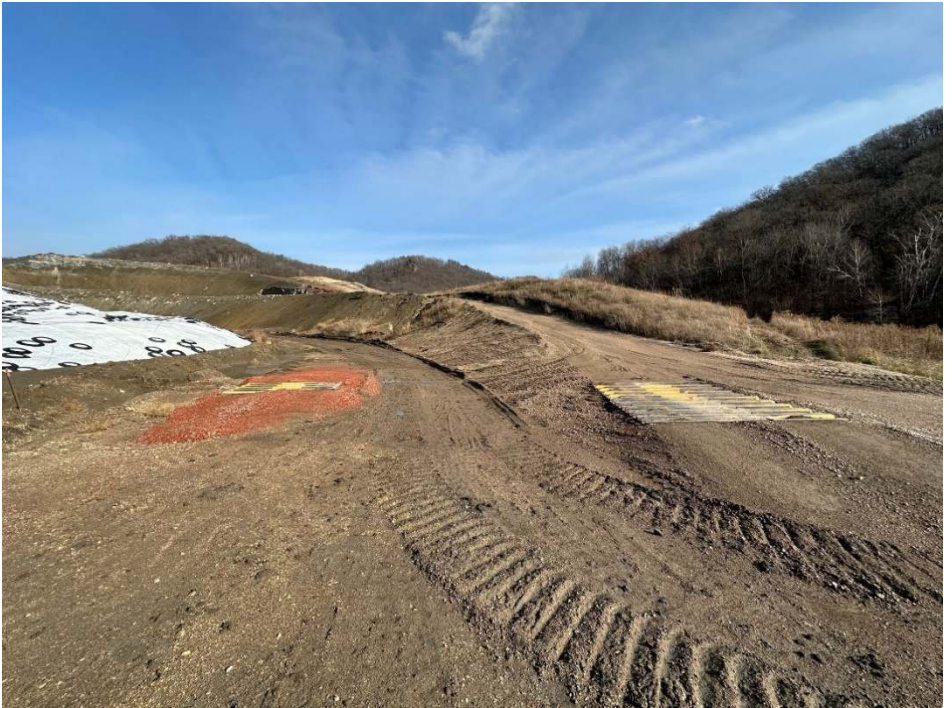
<b>Photo No.</b> 10	<b>Date</b> 11/09/2022

<b>Description:</b> Wheel shakers installed at egress of Phase IV Landfill to minimize/prevent tracking.

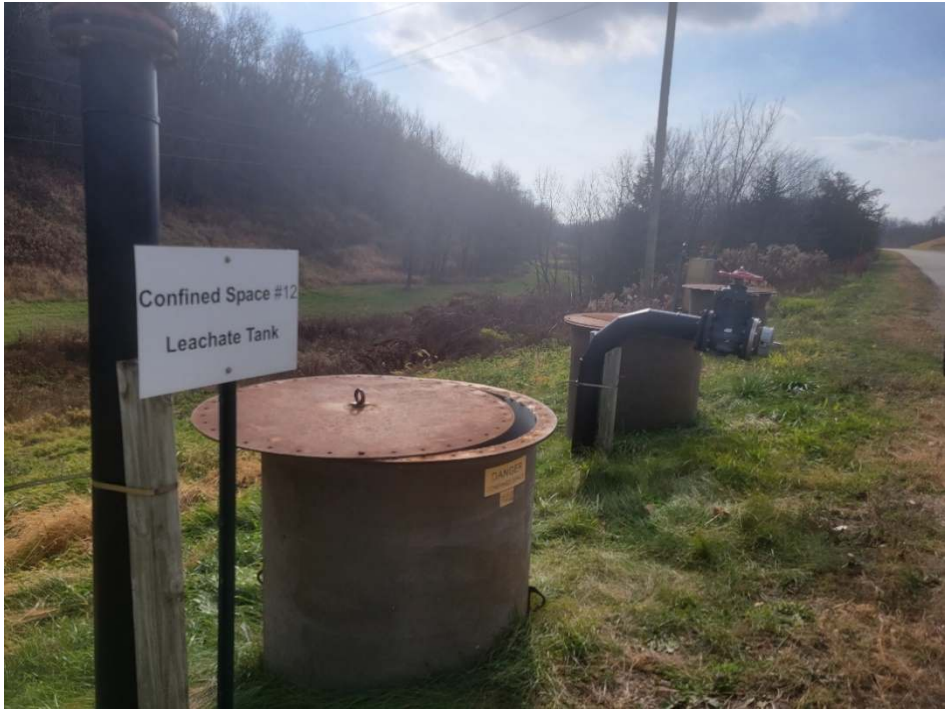
<b>Description:</b> Leachate tank surface features; cleared, accessible, and in good working order. Observed leachate flowing into the tank.
