Subject: Alma Off-Site Disposal Facility – Phase IV Landfill  
2021 Annual Inspection by a Professional Engineer

PROJECT/PROPOSAL NAME	PREPARED		CHECKED		PROJECT/PROPOSAL NO.
	By:	Date:	By:	Date:	
Dairyland Power Cooperative Phase IV, Alma Off-site Disposal Facility	J. Hotstream	11.10.2021	T. Martin	12/2/21	421717.0000

## Landfill Annual Inspection Report

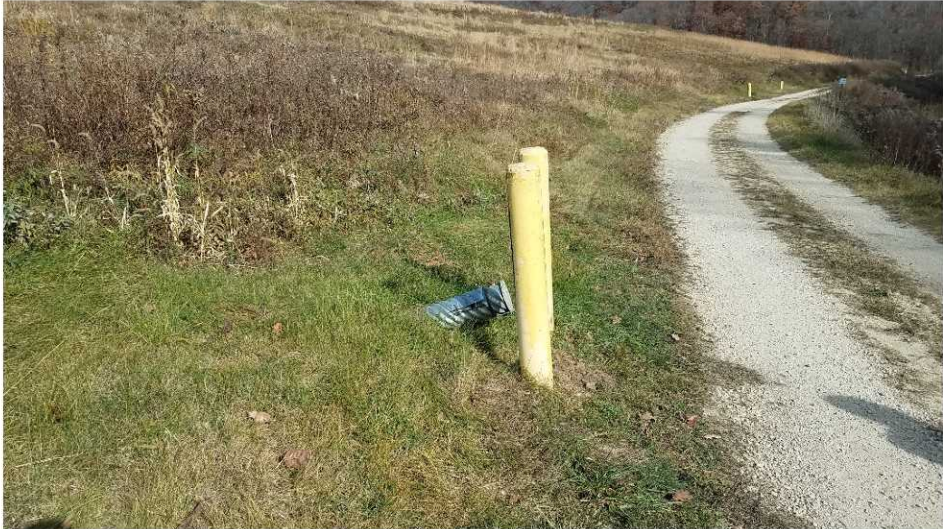
<b>Photo No.</b> 3	<b>Date</b> 11/10/2021

<p><b>Description:</b> Perimeter road is well maintained and provides access around the landfill. Leachate headwell protected by bollards. In background of photo, vegetation established on Area 1 and Area 2 final cover.</p>

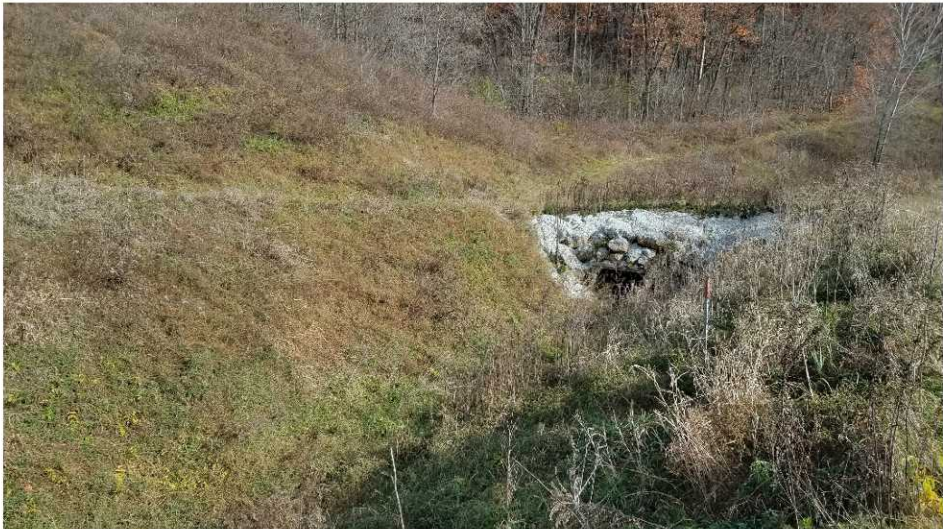
<b>Photo No.</b> 6	<b>Date</b> 11/10/2021	
<b>Description:</b> Box culvert to improve storm water conveyance around perimeter of site. Grouted riprap protects sideslopes at transition. No obstructions observed in the perimeter ditch or at conveyance structures.

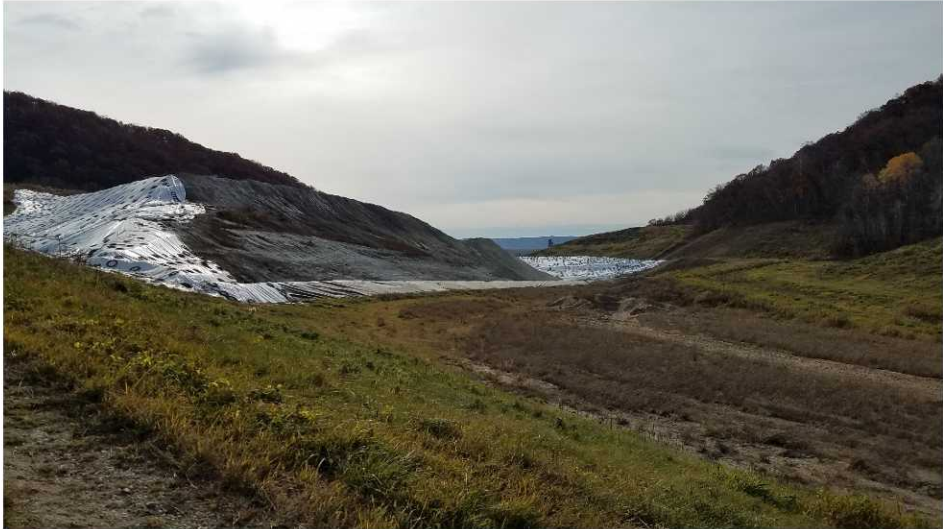
<b>Client Name:</b> Dairyland Power Cooperative		<b>Site Location:</b> Phase IV Landfill, Alma Off-Site Disposal Facility	<b>Project No.:</b> 421717.0000
<b>Photo No.</b> 7	<b>Date</b> 11/10/2021

<b>Description:</b> Active filling area of the landfill (Cell 3A and 3B). Phase delineation berm in the foreground. No evidence of unstable conditions. No fugitive dust observed.			
<b>Photo No.</b> 8	<b>Date</b> 11/10/2021

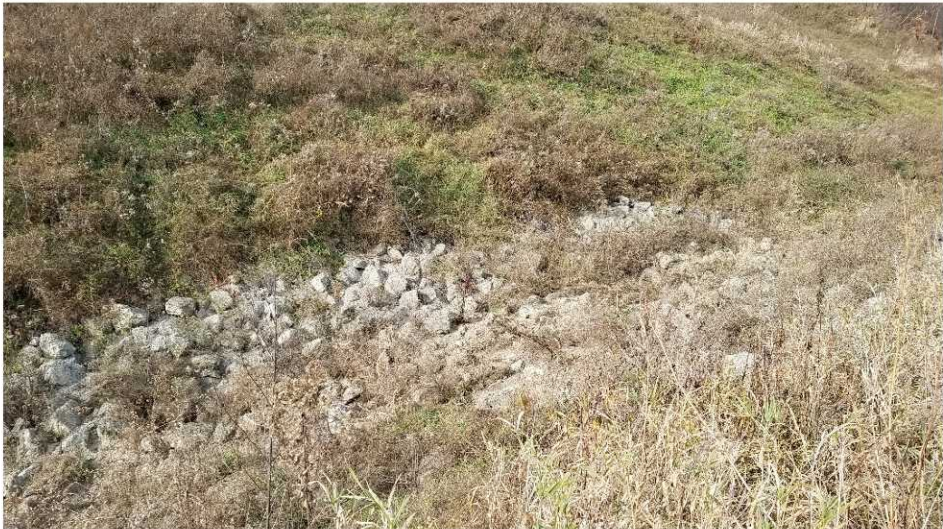
<b>Description:</b> Riprap ditch protection in perimeter ditch. Minor vegetative growth not impacting performance. Dense vegetation is established around ditch and ditch is clear of obstructions.

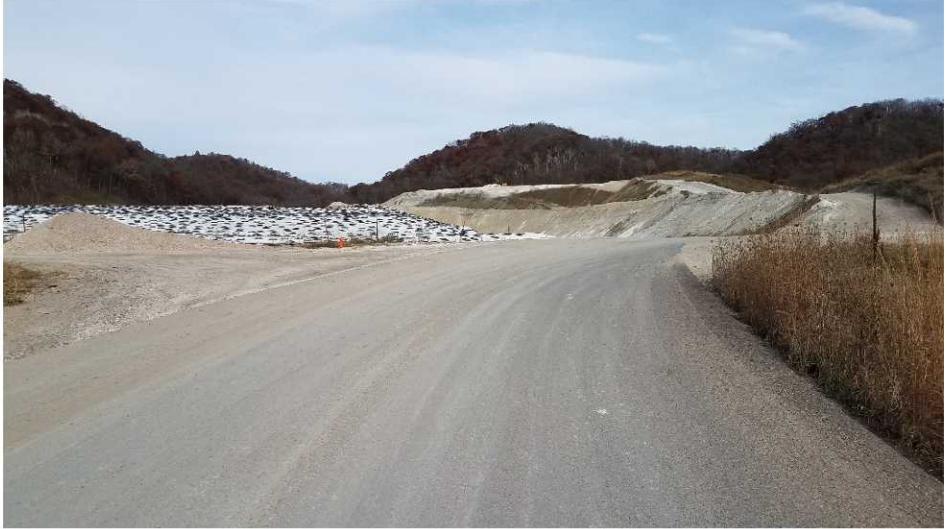
<b>Client Name:</b> Dairyland Power Cooperative		<b>Site Location:</b> Phase IV Landfill, Alma Off-Site Disposal Facility	<b>Project No.:</b> 421717.0000
<b>Photo No.</b> 9	<b>Date</b> 11/10/2021

<b>Description:</b> Asphalt paved access road at entrance filling area. No material observed tracked out of Phase IV.
