Subject: Alma Off-Site Disposal Facility – Phase IV Landfill
2024 Annual Inspection by a Professional Engineer

PROJECT/PROPOSAL NAME Dairyland Power Cooperative Phase IV, Alma Off-site Disposal Facility	PREPARED		CHECKED		PROJECT/PROPOSAL NO. 563618.0000
	By: B. Kahnk	Date: 11/26/2024	By: T. Martin	Date: 12/9/2024

Landfill Annual Inspection Report

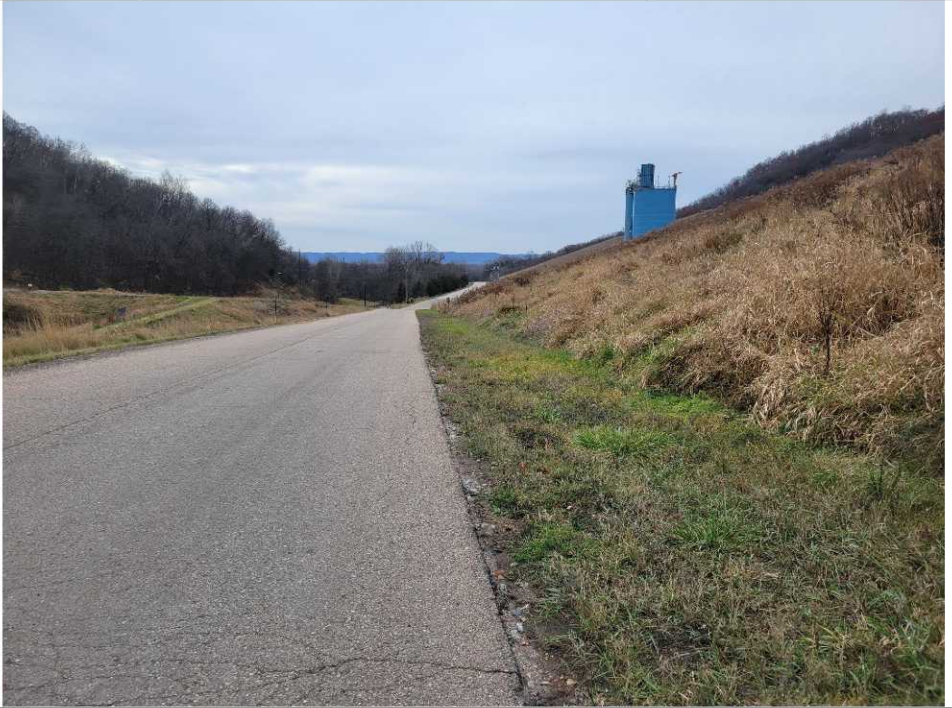
Client Name: Dairyland Power Cooperative		Site Location: Phase IV Landfill Alma Off-Site Disposal Facility	Project No.: 563618.0000
Photo No. 1	Date 11/13/2024

Description: Asphalt paved site entrance road looking south towards the entrance to the facility and Highway 35.			
Photo No. 2	Date 11/13/2024

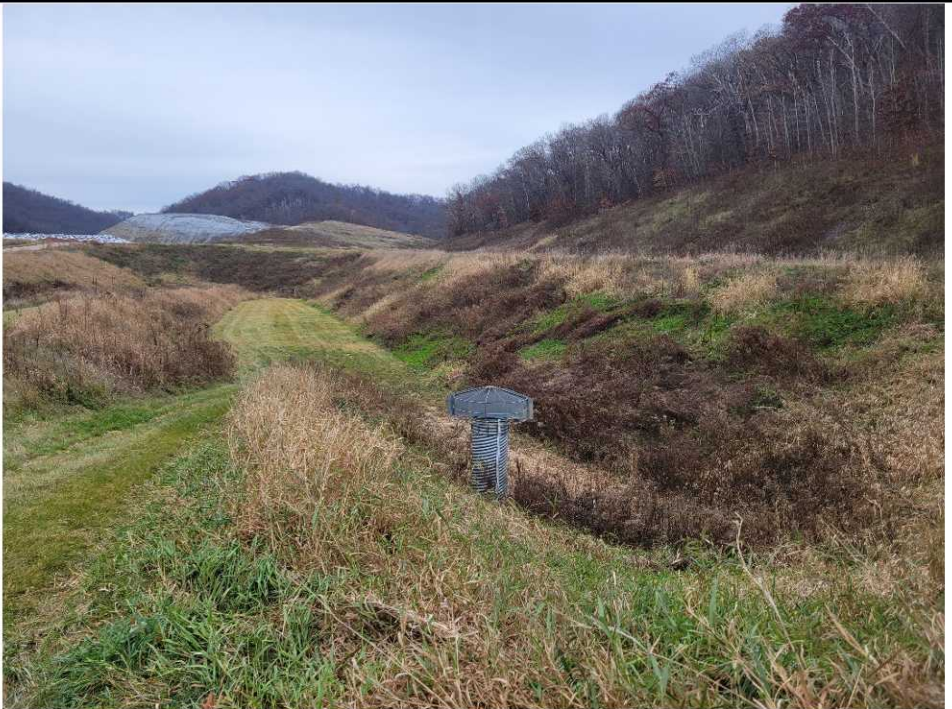
Comments: Basin was dry, no standing water. Continue to monitor vegetation.

Description: Sedimentation Basin 1 outlet. Vegetation established at the base. Gravel placed surrounding base of outlet pipe. No distressed vegetation or sloughing observed on the sideslopes. No standing water observed.

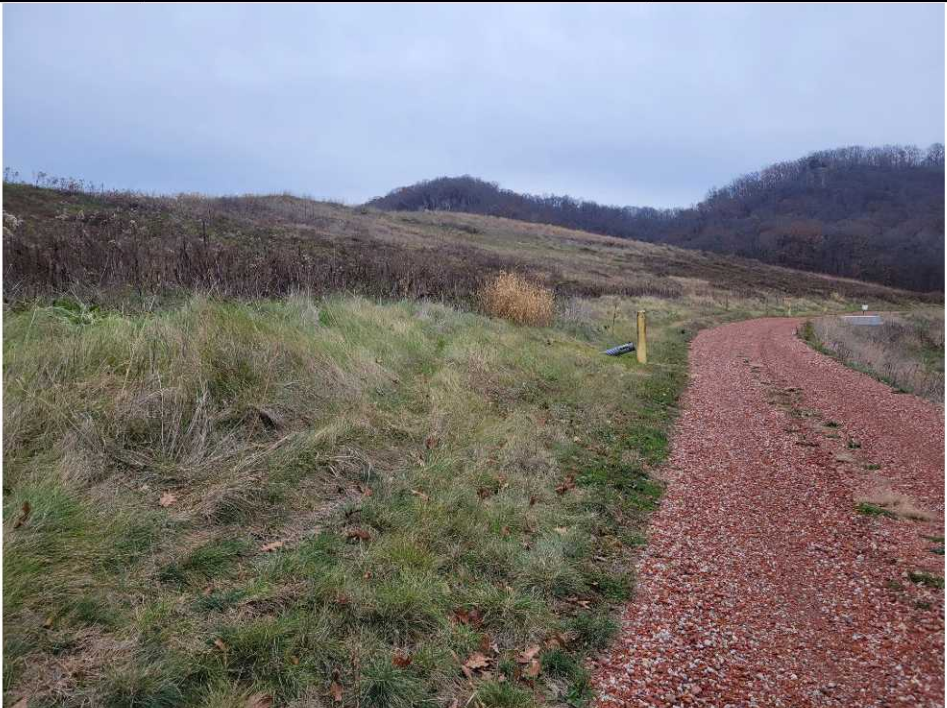
Client Name: Dairyland Power Cooperative		Site Location: Phase IV Landfill Alma Off-Site Disposal Facility	Project No.: 563618.0000
Photo No. 3	Date 11/13/2024

Description: Perimeter road is well maintained and provides access to the east and north sides of the landfill. Leachate headwell protected by bollards. In background of photo, vegetation established on Area 1 and Area 2 final cover.			
Photo No. 4	Date 11/13/2024

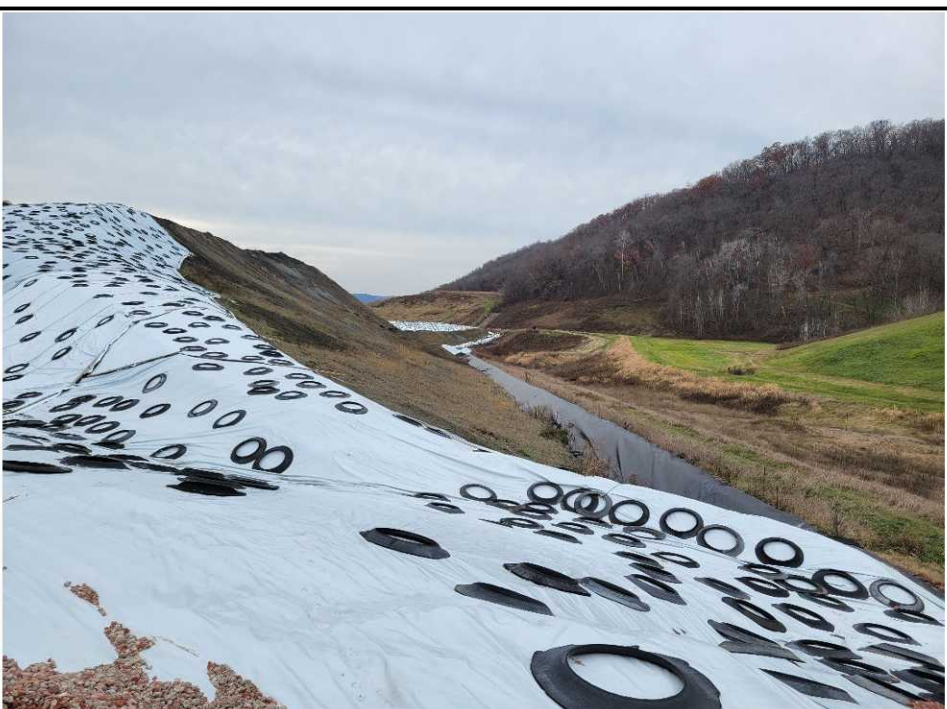
Comments: Exposed geomembrane not showing signs of deterioration or damage. Care Should continue to be taken during ash placement so that ash does not pile up along the delineation berm and freeboard for any liquids is maintained.

Description: CCR filling area showing Cell 3 delineation berm. Sufficient space and berm height provided to control runoff within the landfill. In the foreground of the photo, the temporary white geosynthetic cover is visible with ballast materials to protect from wind uplift.

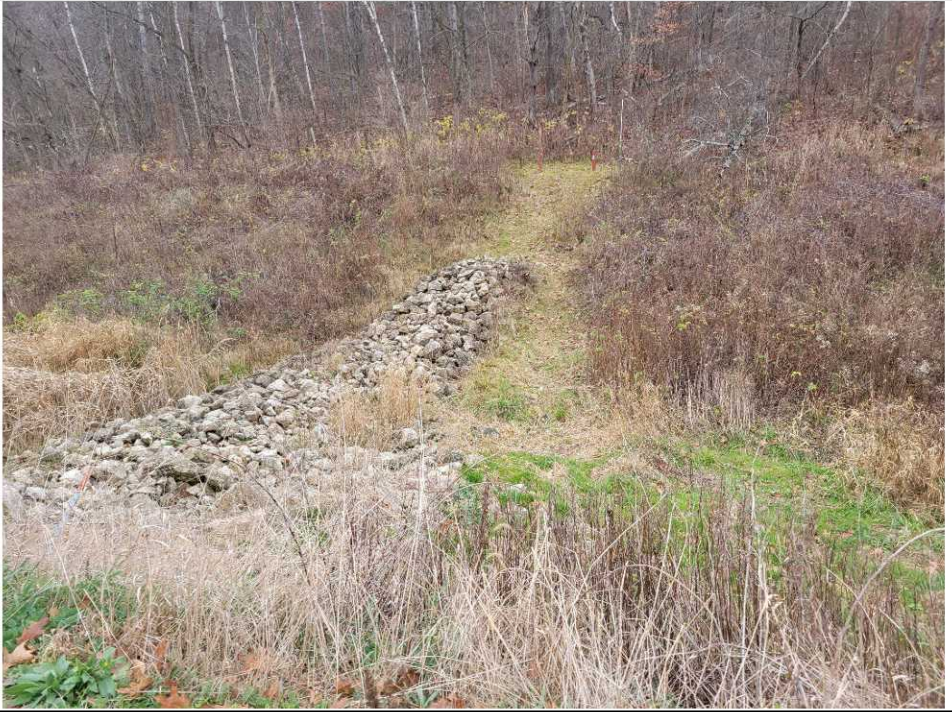
Client Name: Dairyland Power Cooperative		Site Location: Phase IV Landfill Alma Off-Site Disposal Facility	Project No.: 563618.0000
Photo No. 5	Date 11/13/2024

Description Perimeter drainage ditch with rock check dam.			
Photo No. 6	Date 11/13/2024

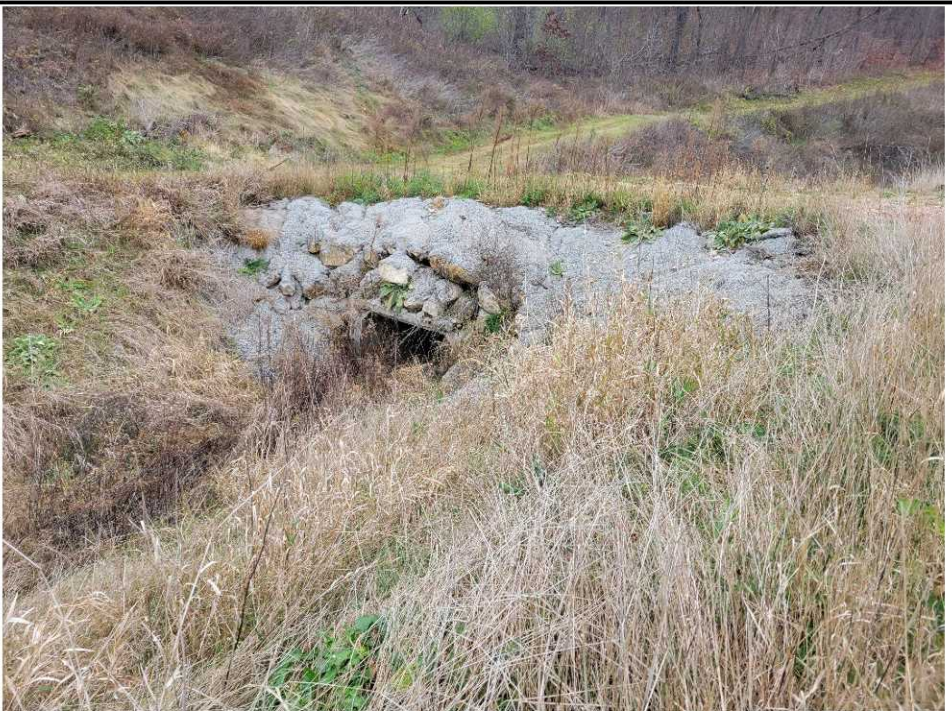
Perimeter Drainage Ditches: Erosion prevented by vegetation, areas around inlets are clear and protected by stone. Minor amount of woody vegetation observed in perimeter drainage ditches. Minor ponding was observed in perimeter drainage ditch along with several large branches.

Description: Box culvert to accommodate storm water conveyance around perimeter of site. Grouted riprap protects sideslopes at transition. Woody debris observed in portions of drainage ditches. No obstructions observed at the culvert or at conveyance structures.

Comments: Continue to keep drainage ditches clear. Remove branch debris from drainage ditches. Continue to monitor ditches for woody vegetation and clear the vegetation when observed. Continue to inspect for ponding within the drainage ditches, regrade if significant ponding is observed. No other concerns at this time.

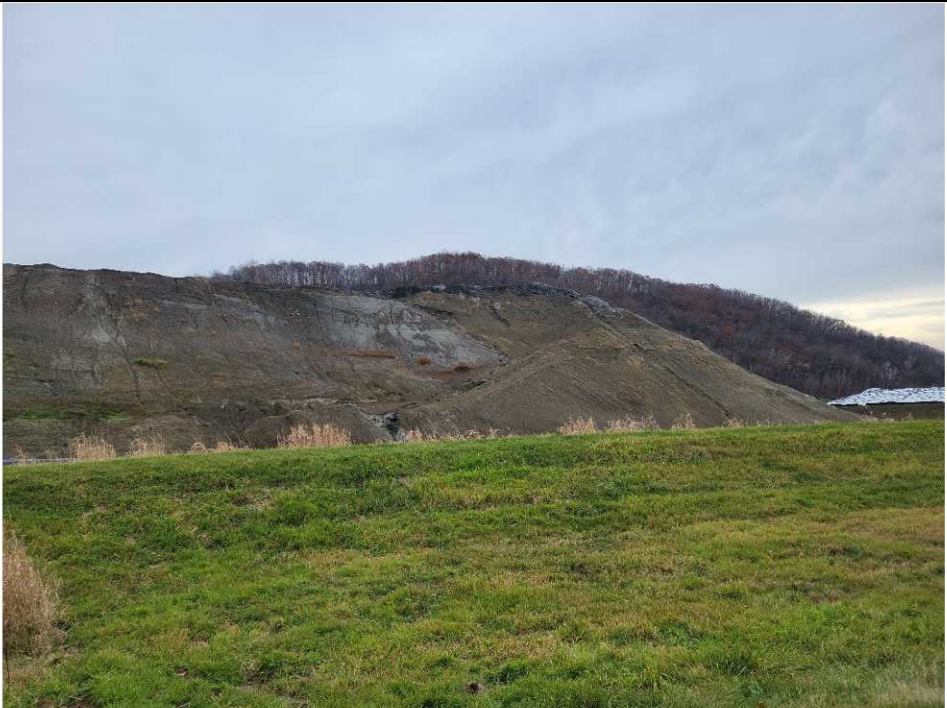
Client Name: Dairyland Power Cooperative		Site Location: Phase IV Landfill Alma Off-Site Disposal Facility	Project No.: 563618.0000
Photo No. 7	Date 11/13/2024

Description: Active filling area of the landfill (Cell 3A and 3B). Phase delineation berm in the foreground. No evidence of unstable conditions.			
Photo No. 8	Date 11/13/2024

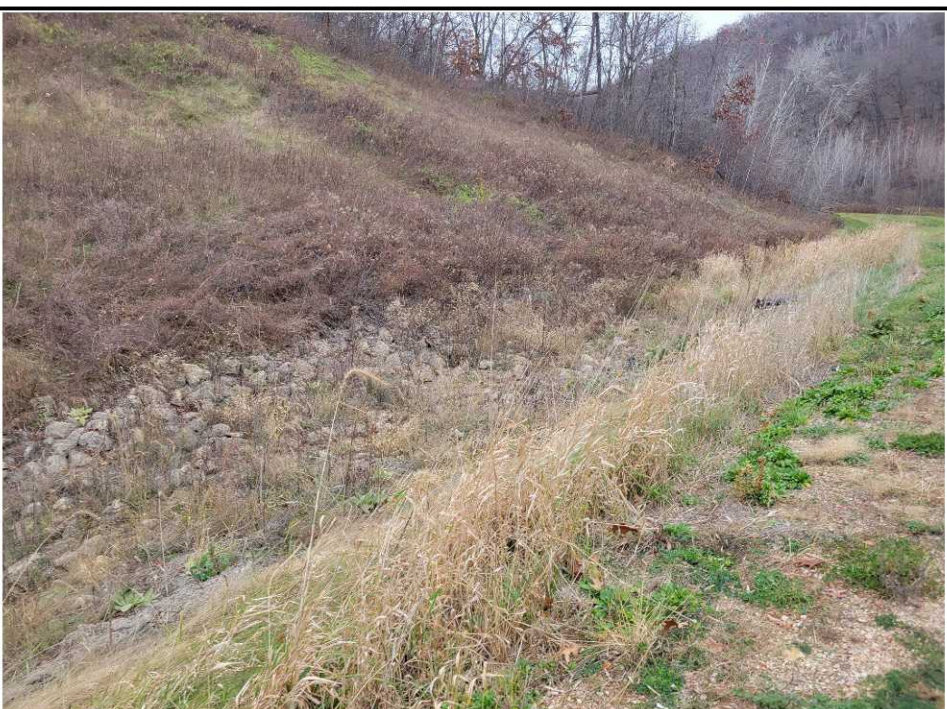
Description: Grouted riprap in perimeter ditch displays no signs of undermining. Vegetative growth not impacting performance. Dense vegetation is established around ditch and ditch is clear of obstructions.

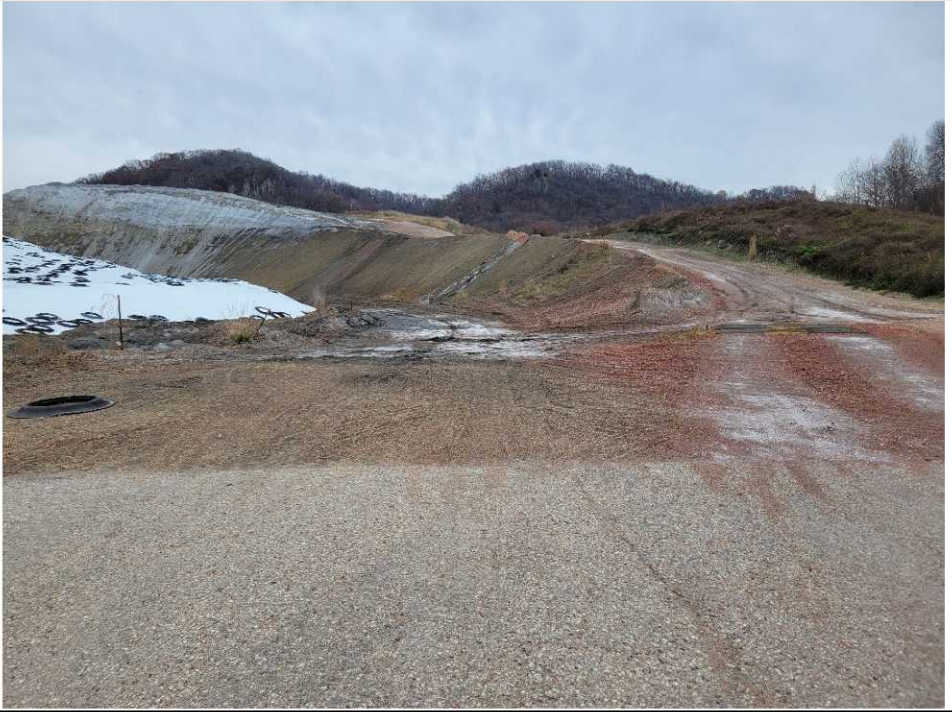
Client Name: Dairyland Power Cooperative		Site Location: Phase IV Landfill Alma Off-Site Disposal Facility	Project No.: 563618.0000
Photo No. 9	Date 11/13/2024

Description: Asphalt paved access road at entrance filling area. No tracking of CCR material was observed beyond the permitted limits of waste.			
Photo No. 10	Date 11/13/2024

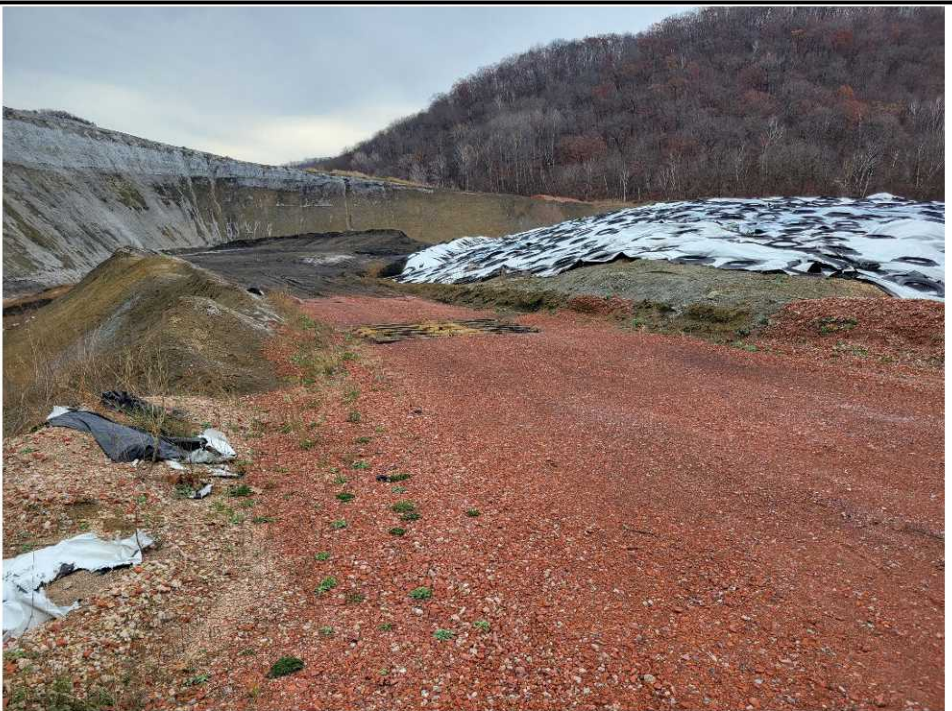
Description: Wheel shakers installed at egress of Phase IV Landfill to minimize tracking of CCR material outside the permitted limits of waste.

Comments: Continue to sweep landfill egress as needed, especially following rain events.

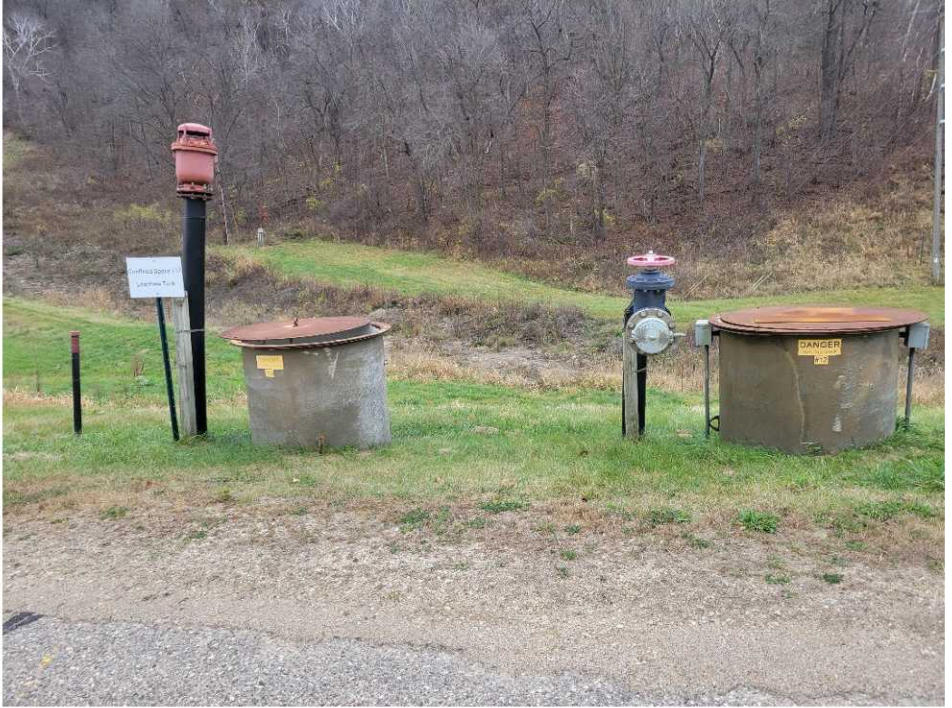
Client Name: Dairyland Power Cooperative		Site Location: Phase IV Landfill Alma Off-Site Disposal Facility	Project No.: 563618.0000
Photo No. 11	Date 11/13/2024

Description: Leachate tank surface features; clear, accessible, and in good working order. Observed leachate flowing into the tank.
