Subject: Alma Off-Site Disposal Facility - Annual Inspection by a Professional Engineer

PROJECT/PROPOSAL NAME	PREPARED		CHECKED		PROJECT/PROPOSAL NO.
Dairyland Power Cooperative; Phase IV Alma Off-site Disposal Facility	By: J. Hotstream	Date: 11/15/2018	By: T. Martin	Date: 12/13/2018	243332.0004

### Landfill Annual Inspection Report

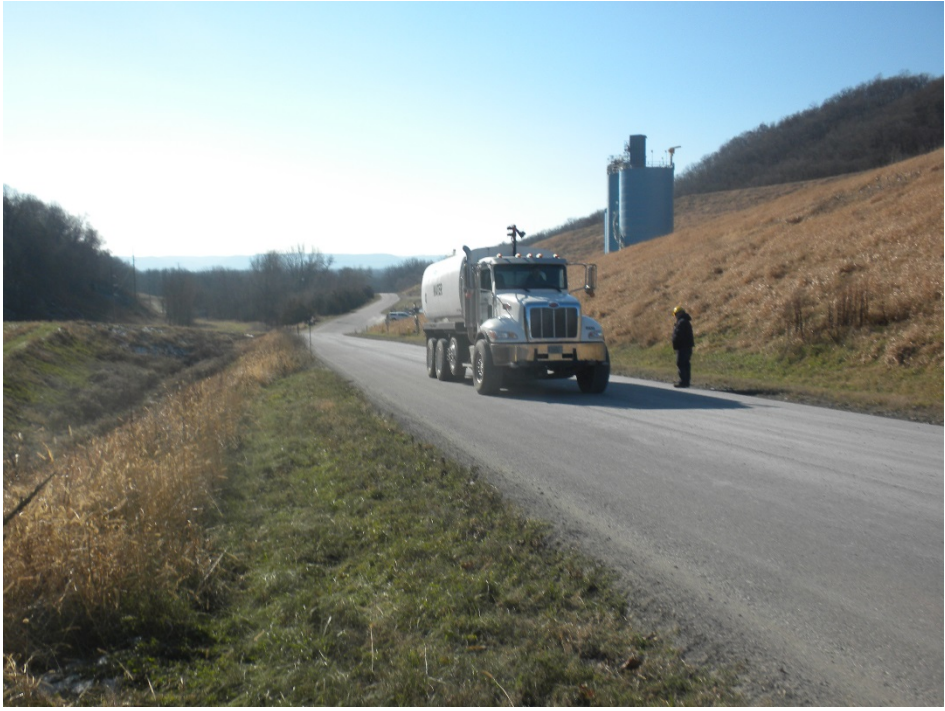
1	11/15/2018		
<b>Description:</b> Asphalt paved site entrance road looking south. Water truck mobilized to moisture condition top of waste.			
Photo No.	Date

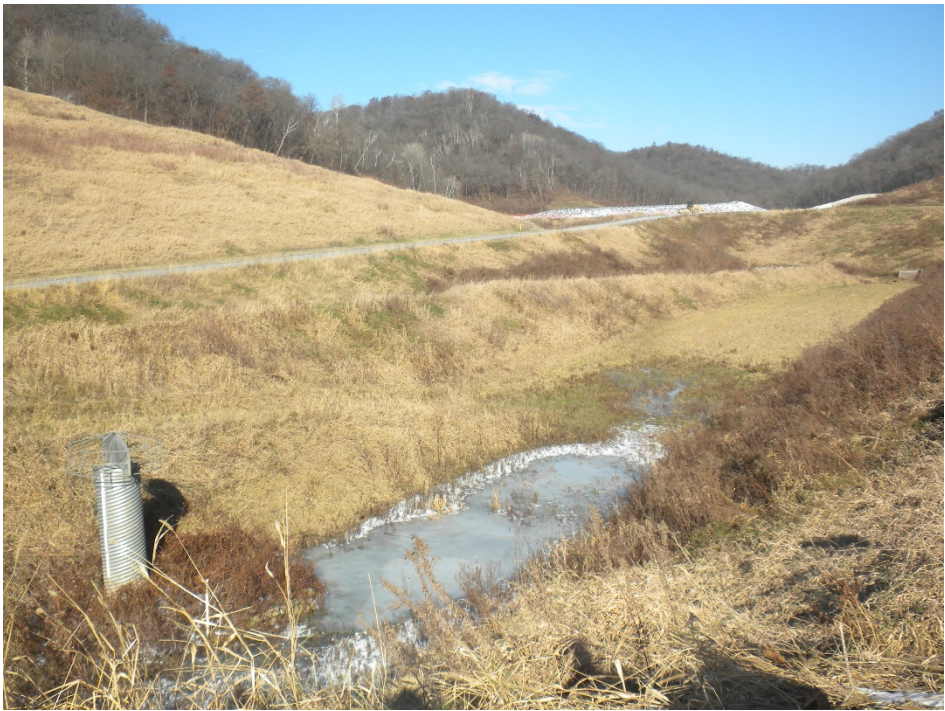
Outlets Operational: Yes, clear, no debris and not deformed; stone filter at base

Comments: Thin accumulation of frozen water at base. Outlet appears to be functioning properly.

2	11/15/2018		
<b>Description:</b> Sedimentation Basin 1 outlet. Vegetation established in the base. Gravel placed surrounding base of outlet pipe.

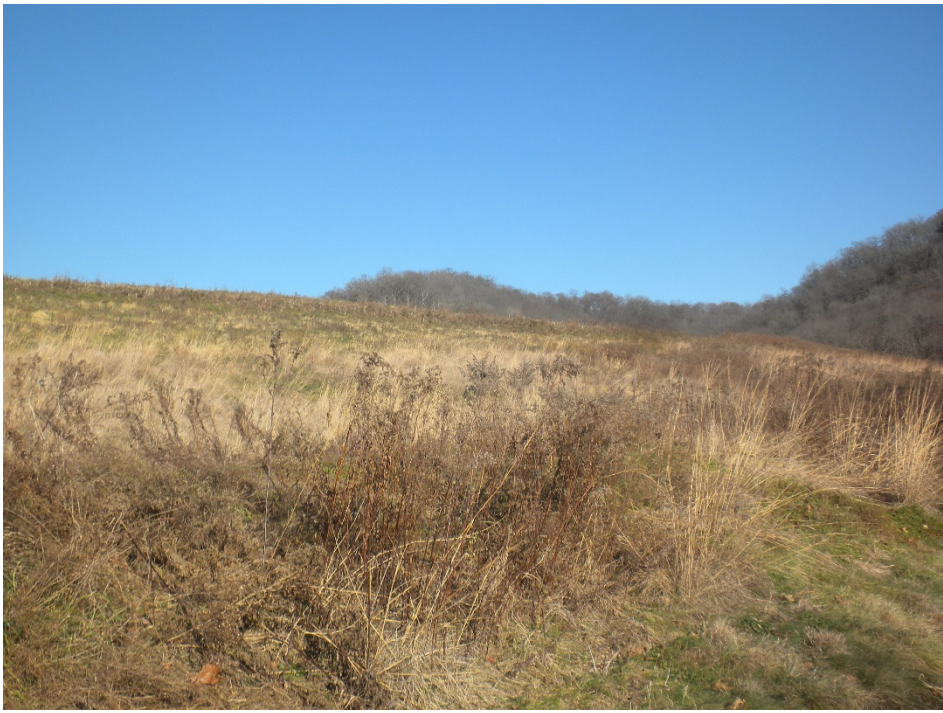
Vegetation Condition: Dense, Good Standing Native Prairie Vegetation Present

Comments: Well maintained. Some drainage discharge through final cover drains.

3	11/15/2018		
<b>Description:</b> Vegetation established on Area 1 and Area 2 final cover.			
Photo No.	Date

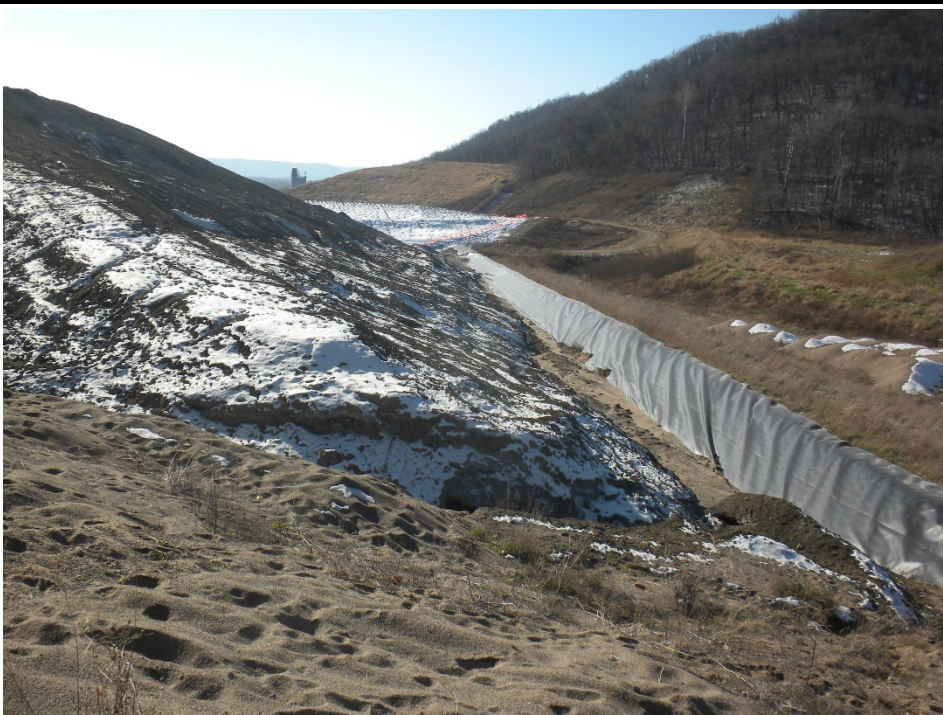
4	11/15/2018		
<b>Description:</b> CCR filling area showing Cell 3 delineation berm. Sufficient space and berm height provided to control runoff within the landfill.

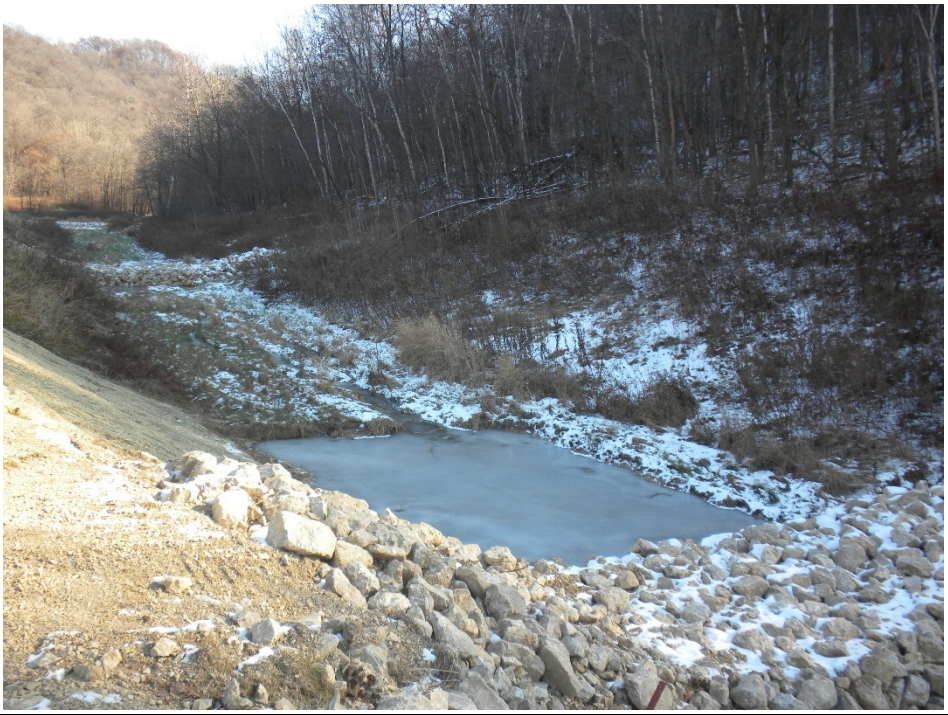
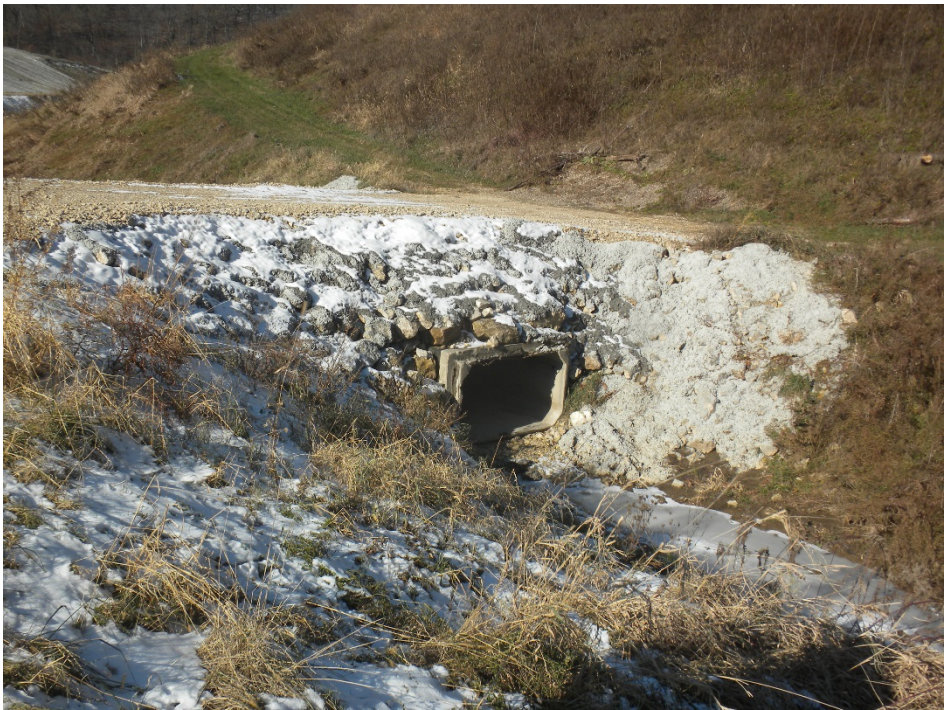
5	11/15/2018		
Description

Comments: Stormwater controls are well-maintained at the site. Good drainage and conveyance to the sedimentation basin, no obstructions observed. Recent reconstruction of check dams along perimeter ditching.

Perimeter drainage ditch with rock check dam. Rock check dams recently restored.			
Photo No.	Date

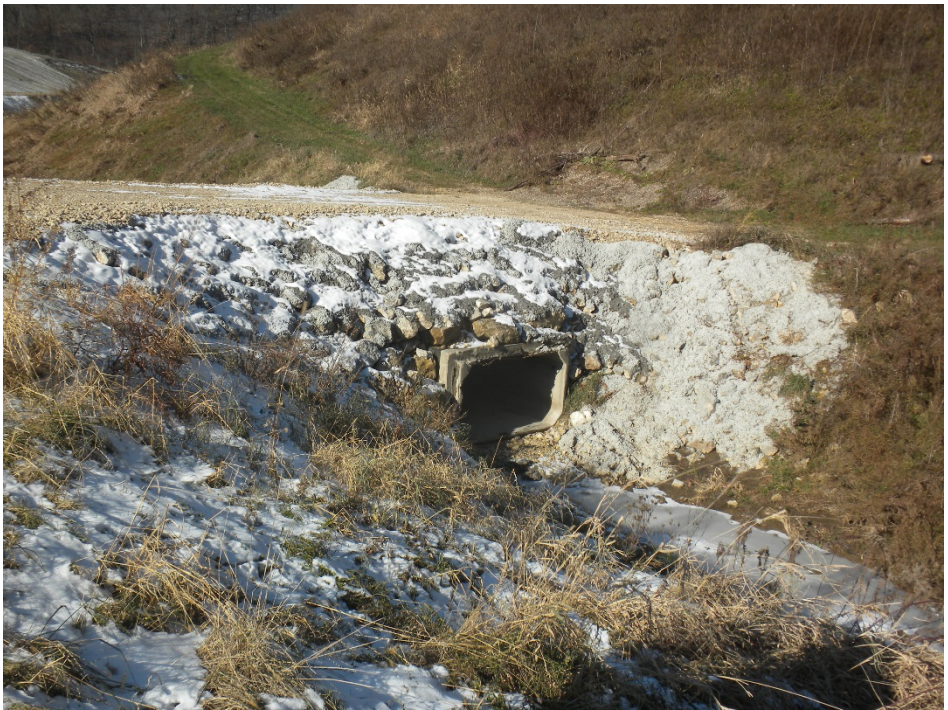
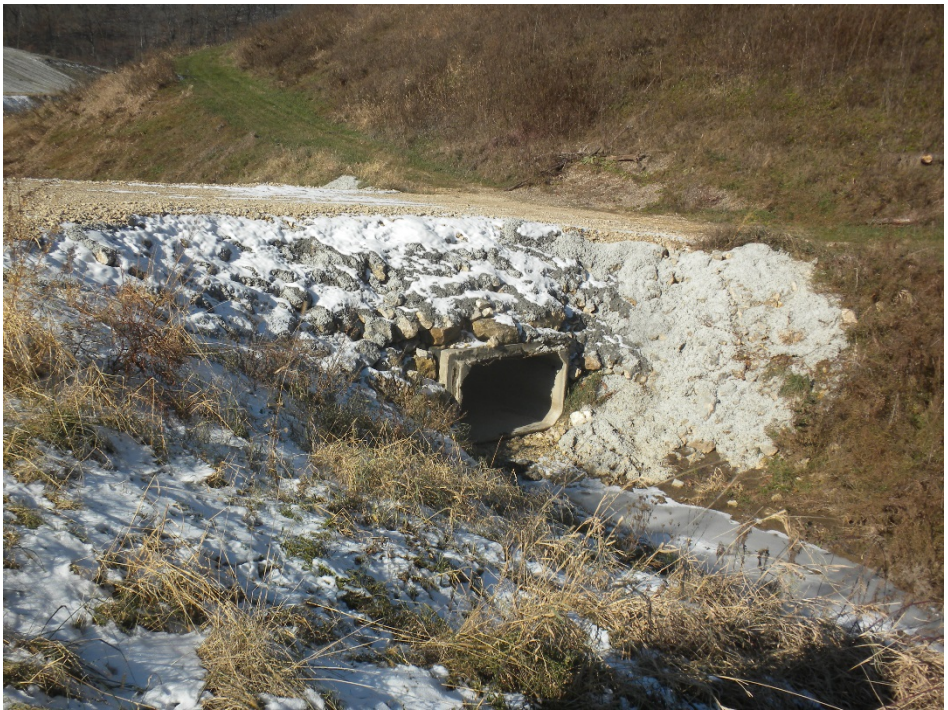
6	11/15/2018		
Description:

- Replaced double culverts with box 4'x6' to control storm water in perimeter ditch on north side of site
- Jetting of leachate collection system performed (3 times) to maintain leachate collection system

Recently installed box culvert to improve storm water conveyance around perimeter of site.
