Subject: Alma Off-Site Disposal Facility – Phase IV Landfill
2023 Annual Inspection by a Professional Engineer

PROJECT/PROPOSAL NAME Dairyland Power Cooperative Phase IV, Alma Off-site Disposal Facility	PREPARED		CHECKED		PROJECT/PROPOSAL NO. 525154.0000
	By: B. Kahnk	Date: 12/01/2023	By: T. Martin	Date: 12/8/2023

Landfill Annual Inspection Report

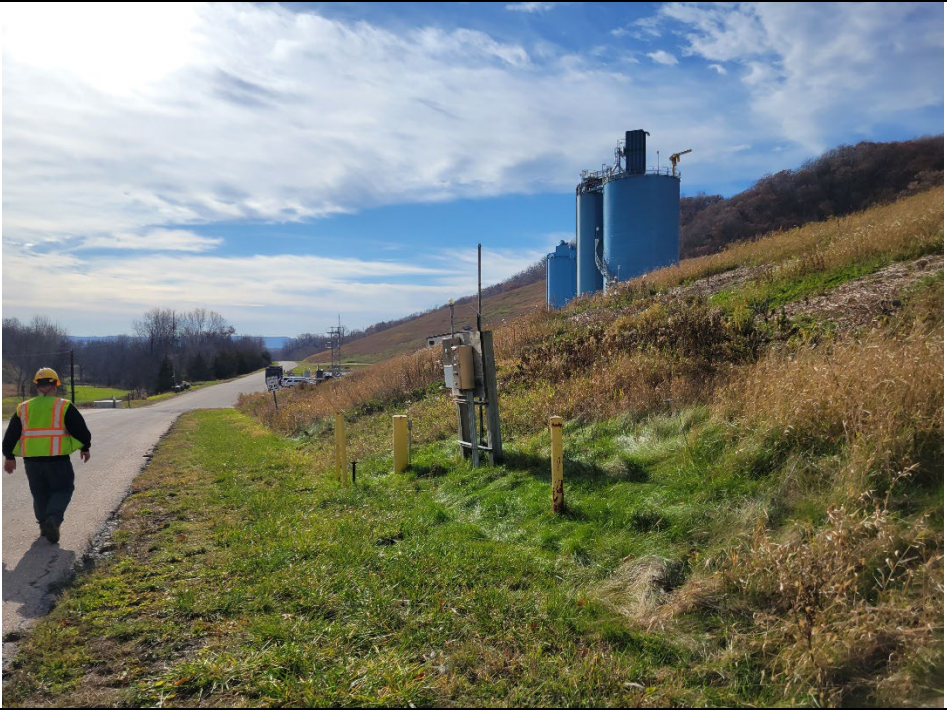
Photo No.	Date	Description
1	11/16/2023	<p>Description: Asphalt paved site entrance road looking towards the entrance to the facility.</p>

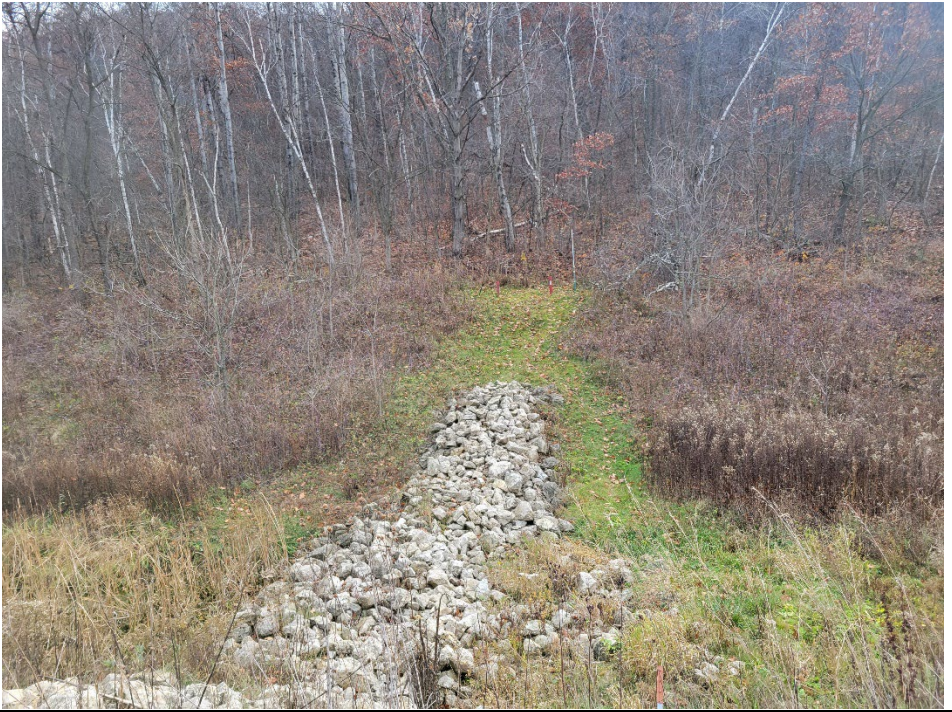
Client Name: Dairyland Power Cooperative		Site Location: Phase IV Landfill Alma Off-Site Disposal Facility	Project No.: 525154.0000
Photo No. 5	Date 11/16/2023

Description Perimeter drainage ditch with rock check dam.			
Photo No. 6	Date 11/16/2023

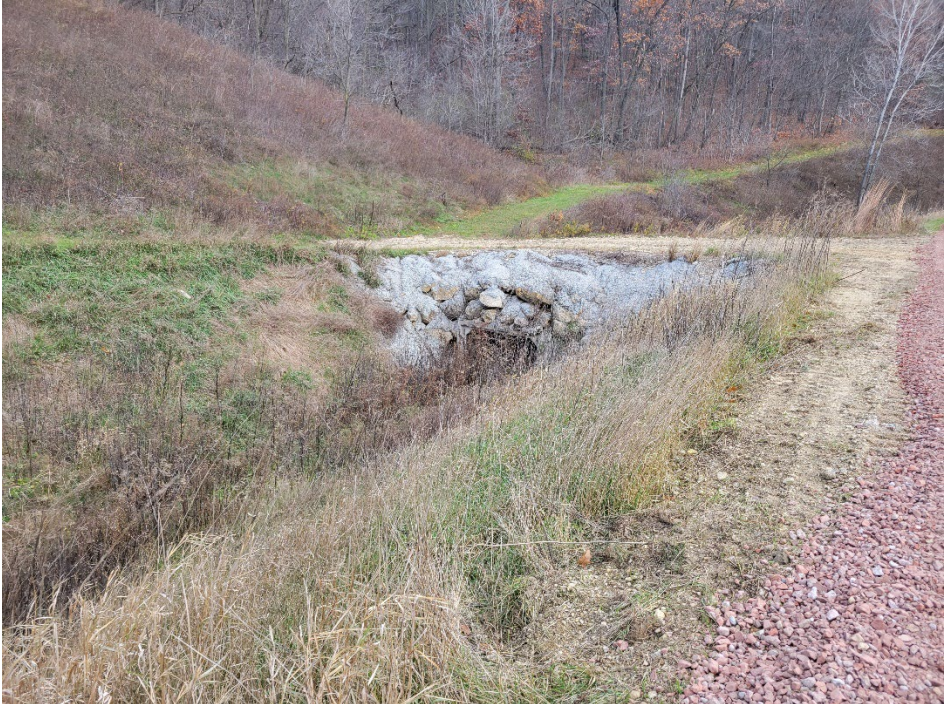
Description: Box culvert to improve storm water conveyance around perimeter of site. Grouted riprap protects sideslopes at transition. No obstructions observed in the perimeter ditch or at conveyance structures.

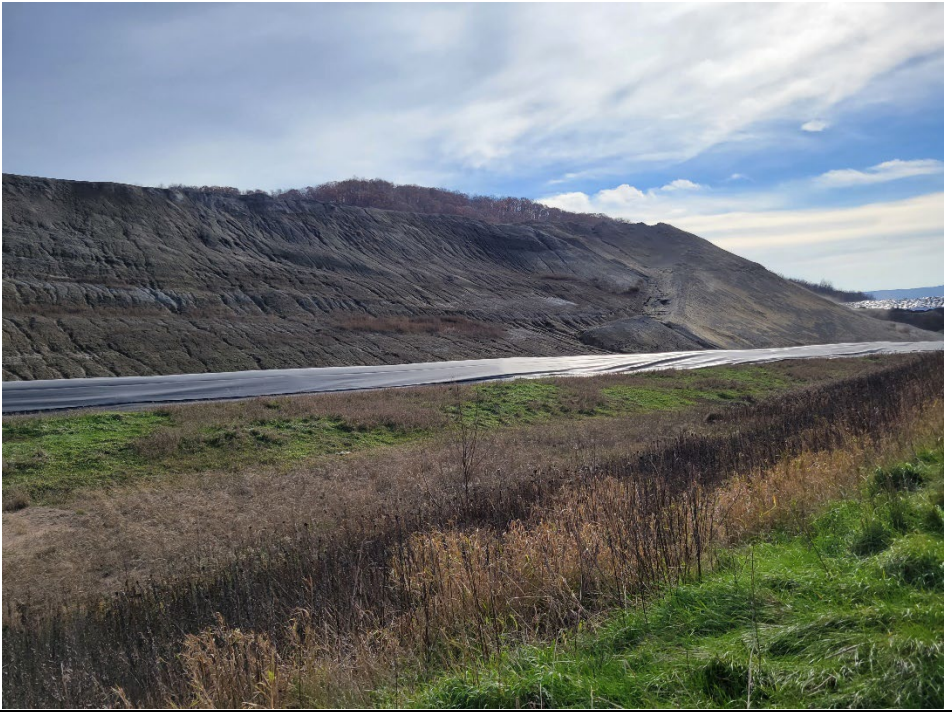
Client Name: Dairyland Power Cooperative		Site Location: Phase IV Landfill Alma Off-Site Disposal Facility	Project No.: 525154.0000
Photo No. 7	Date 11/16/2023

Description: Active filling area of the landfill (Cell 3A and 3B). Phase delineation berm in the foreground. No evidence of unstable conditions.			
Photo No. 8	Date 11/16/2023

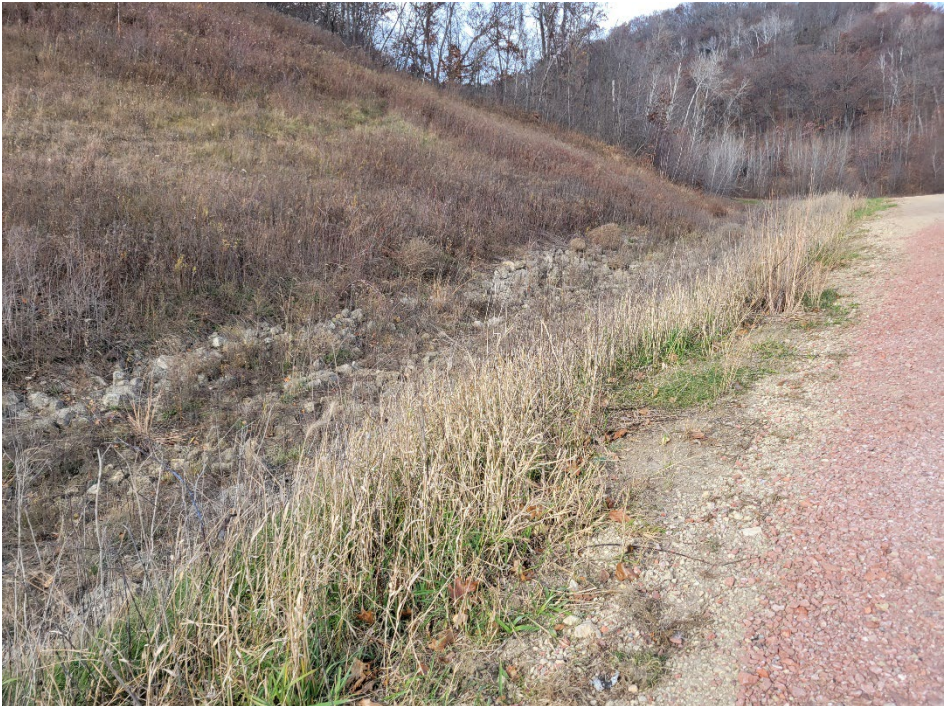
Description: Riprap ditch protection in perimeter ditch. Vegetative growth not impacting performance. Dense vegetation is established around ditch and ditch is clear of obstructions.

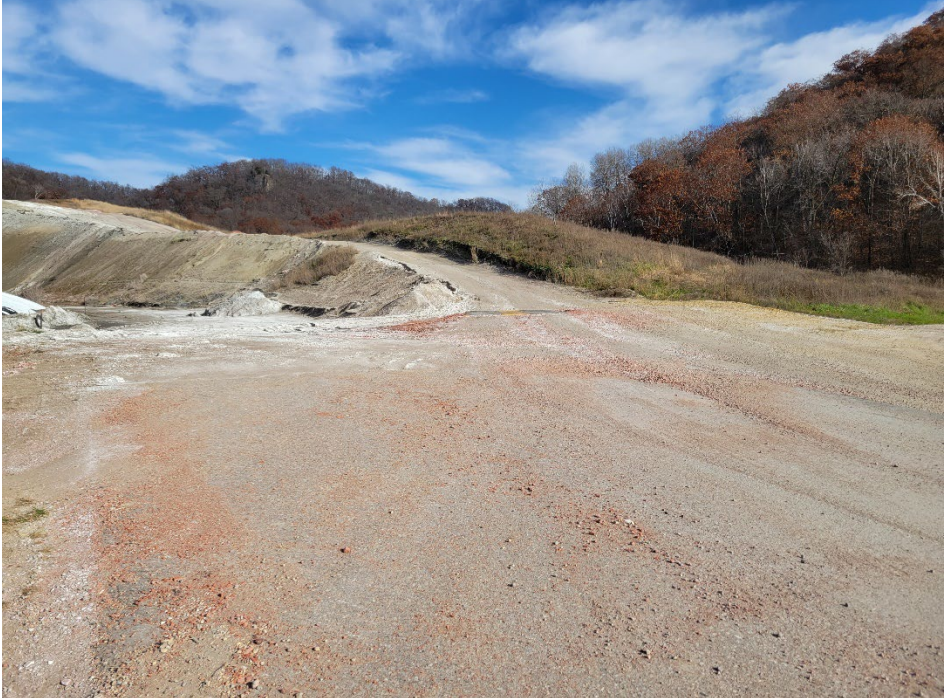
Photo No. 9	Date 11/16/2023

Durable paved, well groomed. New material was recently placed on portions of the perimeter access road. Site should confirm that all vehicles stay entirely on access roads to avoid disturbances along the toe of the final cover slope. Very minor tracking of ash was observed at the egress from Phase IV. No tracking was observed on the remainder of access road.

Description: Asphalt paved access road at entrance filling area. Minor tracking, primarily from recently installed access road base at egress from Phase IV.

Comments: Sweep landfill egress as needed, especially following rain events.

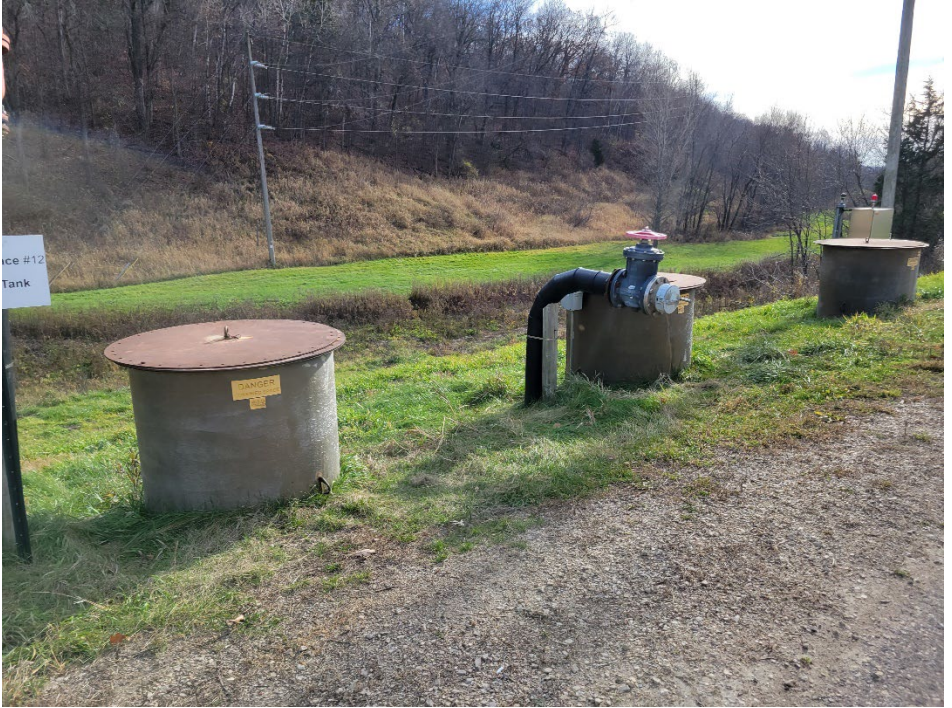
Client Name: Dairyland Power Cooperative		Site Location: Phase IV Landfill Alma Off-Site Disposal Facility	Project No.: 525154.0000
Photo No. 11	Date 11/16/2023

Description: Leachate tank surface features; clear, accessible, and in good working order. Observed leachate flowing into the tank.
