December 17, 2020

Subject: Alma Off-Site Disposal Facility – Phase IV Landfill
Annual Inspection by a Professional Engineer

Landfill Annual Inspection Report

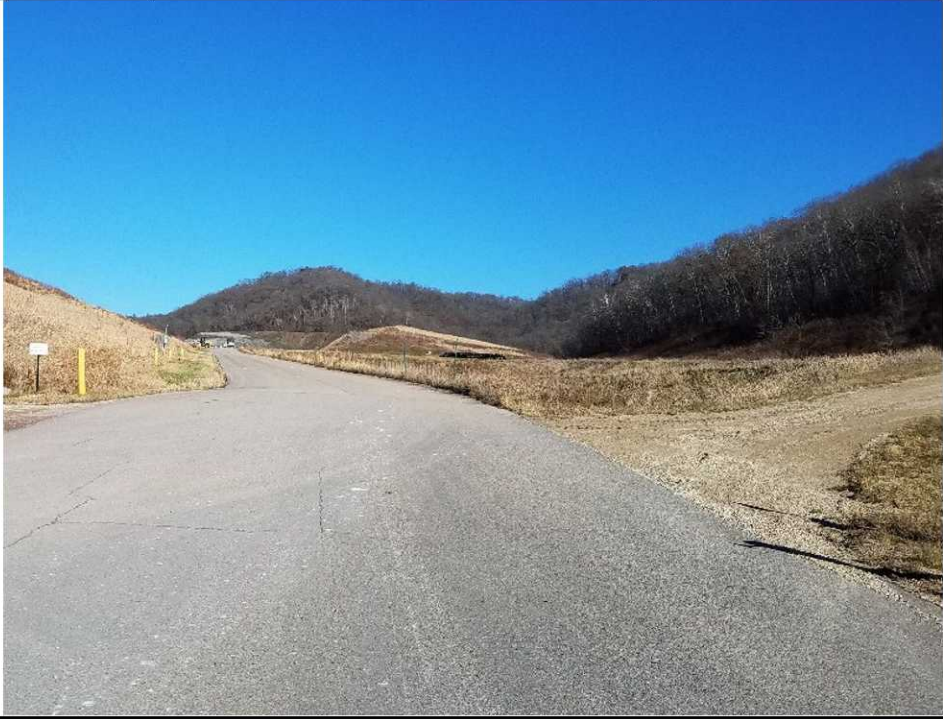
Client Name: Dairyland Power Cooperative		Site Location: Phase IV Landfill, Alma Off-Site Disposal Facility	Project No.: 370477.0000
Photo No. 1	Date 11/11/2020

Description: Asphalt paved site entrance road looking towards the Phase IV landfill.			
Photo No. 2	Date 11/11/2020

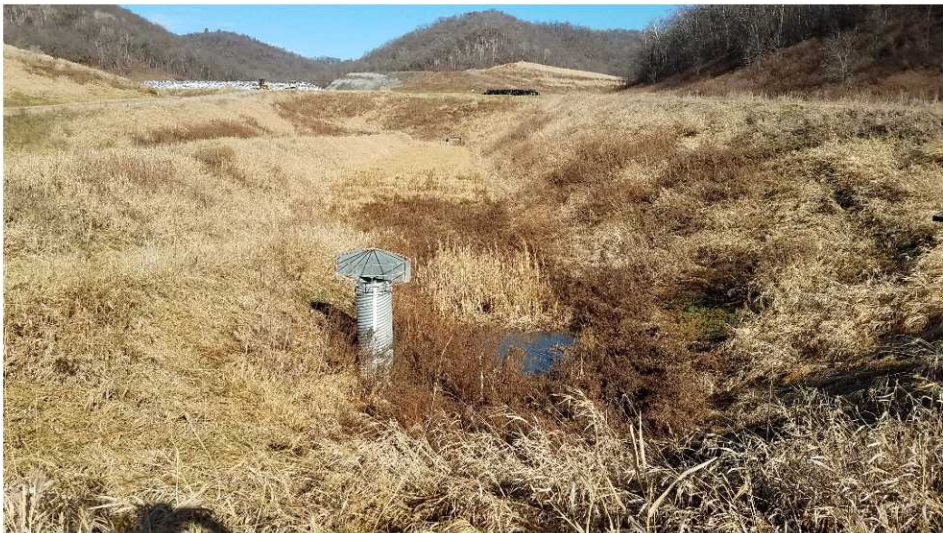
Comments: Shallow accumulation of frozen water at base due to recent precipitation. Outlet appears to be functioning properly.

Description: Sedimentation Basin 1 outlet. Vegetation established in the base. Gravel placed surrounding base of outlet pipe. No distressed vegetation observed in the sideslopes.

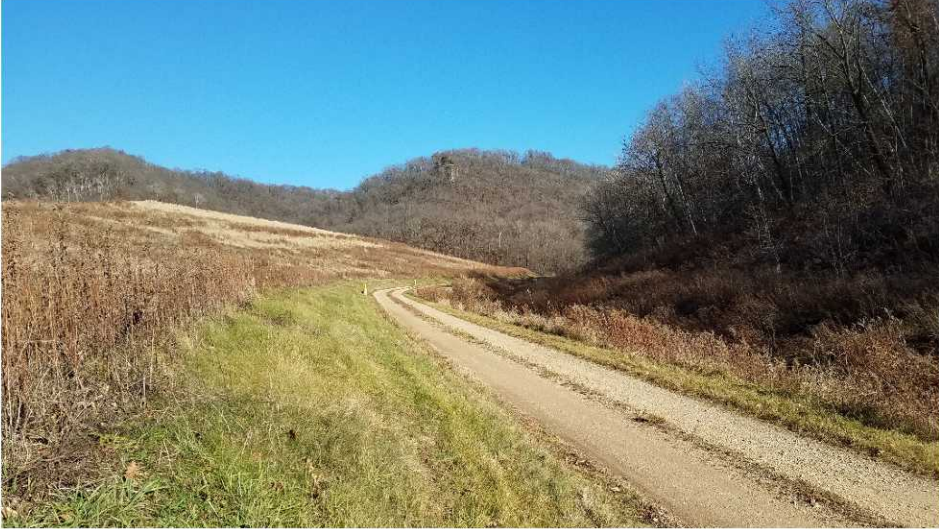
Client Name: Dairyland Power Cooperative		Site Location: Phase IV Landfill, Alma Off-Site Disposal Facility	Project No.: 370477.0000
Photo No. 3	Date 11/11/2020

Description: Vegetation established on Area 1 and Area 2 Final Cover. Perimeter road is well maintained and provides access around the landfill.			
Photo No. 4	Date 11/11/2020

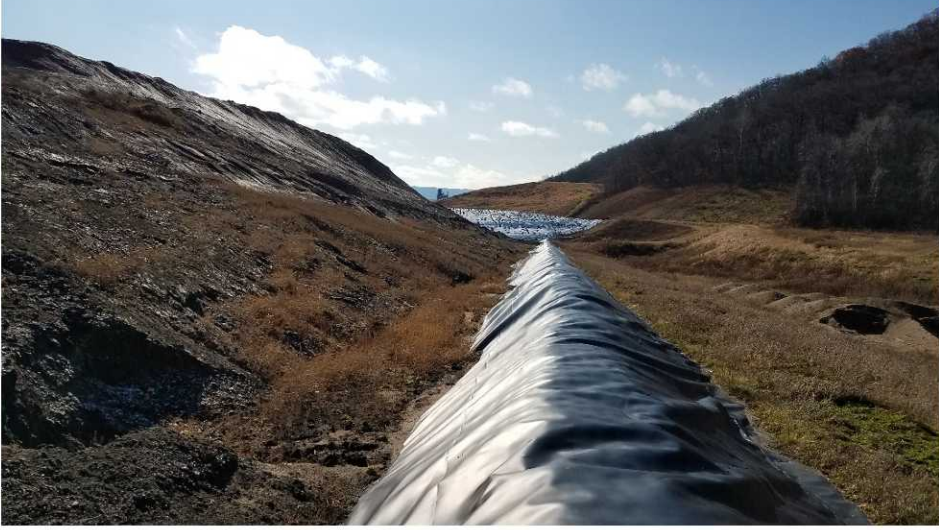
Phase Delineation Berms: Exposed geomembrane cover in good condition, sufficient clearance for containing runoff within the cell.

Description: CCR filling area showing the Cell 3 delineation berm. There is sufficient space and berm height provided to control runoff within the landfill.

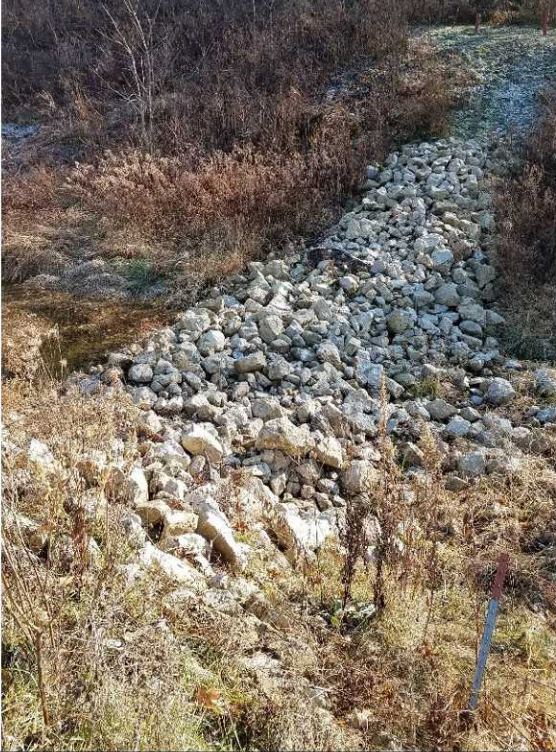
Photo No. 5	Date 11/11/2020	
Description Perimeter drainage ditch with rock check dam. Rock check dams recently restored.

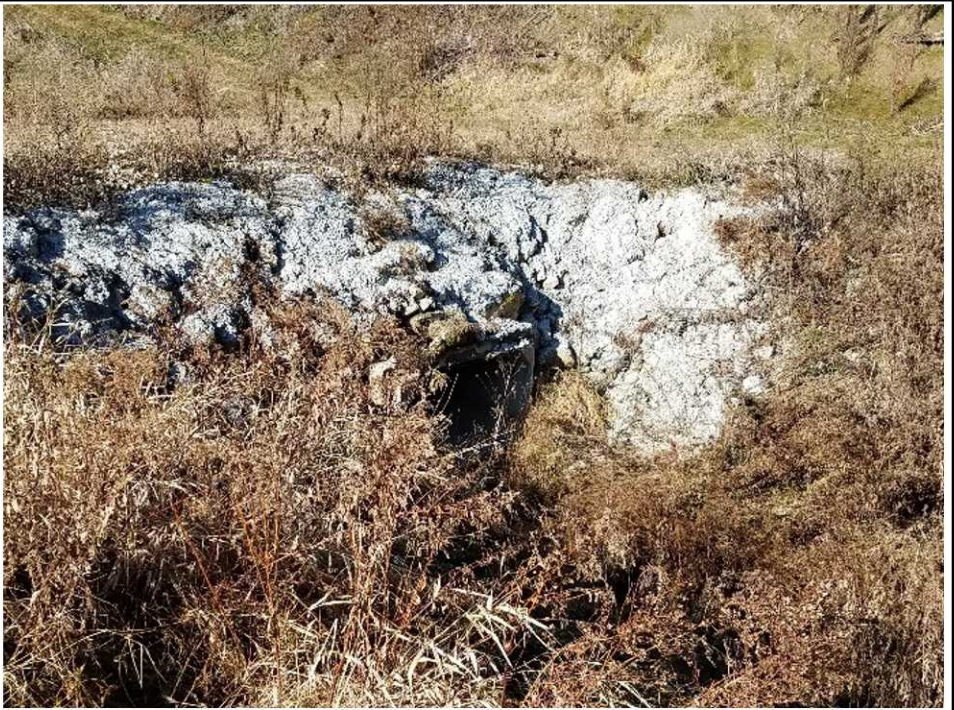
Photo No. 6	Date 11/11/2020	
Description: Box culvert to convey storm water around perimeter of site. Grouted riprap protects sideslopes at transition. No obstructions observed in the perimeter ditch or at conveyance structures.

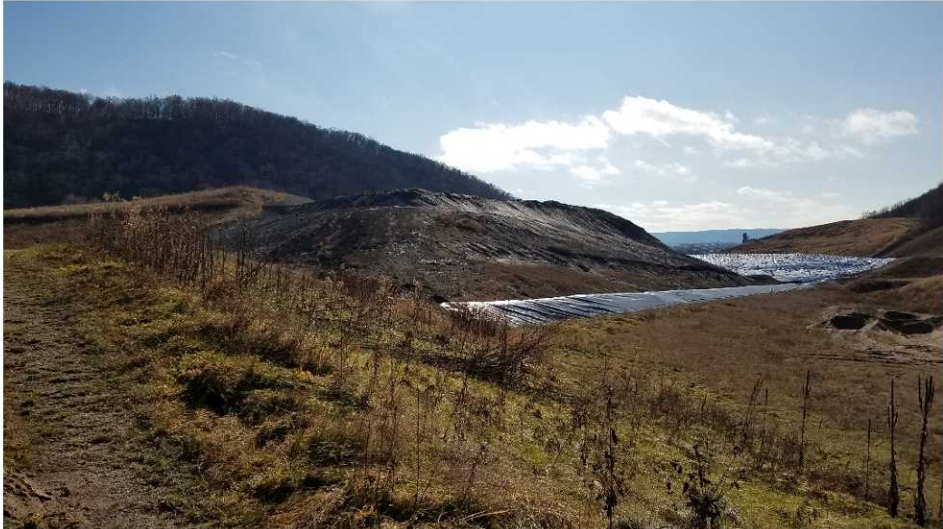
Client Name: Dairyland Power Cooperative		Site Location: Phase IV Landfill, Alma Off-Site Disposal Facility	Project No.: 370477.0000
Photo No. 7	Date 11/11/2020

Description: Active filling area of landfill (Cell 3A and 3B). Phase delineation berm in the foreground. No evidence of unstable conditions. No fugitive dust observed.			
Photo No. 8	Date 11/11/2020

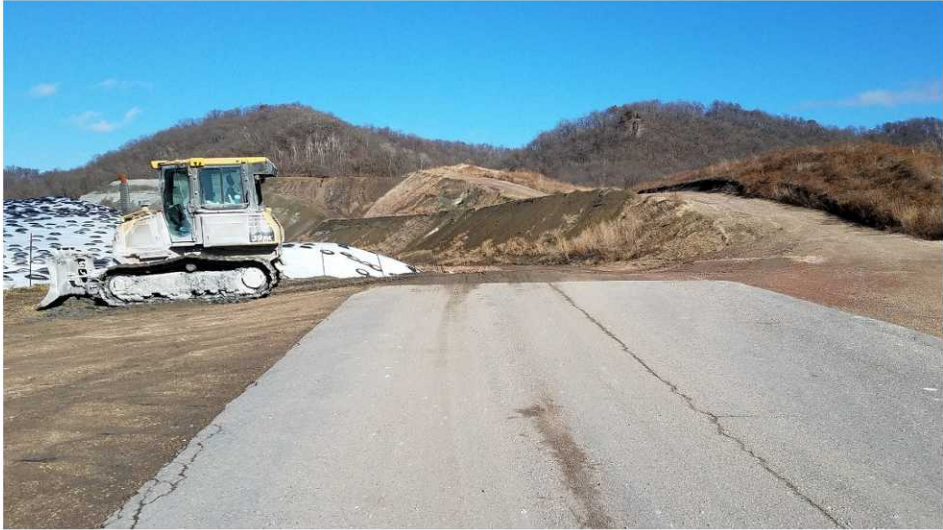
Client Name: Dairyland Power Cooperative		Site Location: Phase IV Landfill, Alma Off-Site Disposal Facility	Project No.: 370477.0000
Photo No. 9	Date 11/11/2020

Description: Asphalt paved access road at entrance to filling area. No material observed tracked out of Phase IV.
